## **PROJECT START**

## **GENERAL CONDITIONS OF THE STUDY AREA**

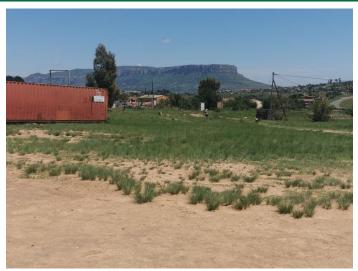
Figure 1: Site where the Sewage Treatment Package Plant (STP) is to be located. Site viewed from the immediate west

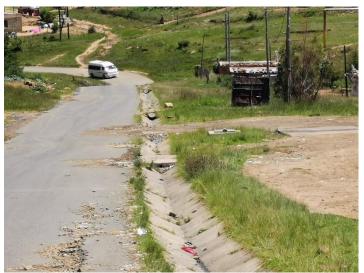
Figure 2: Existing stormwater drainage where the proposed discharged pipeline is to be located

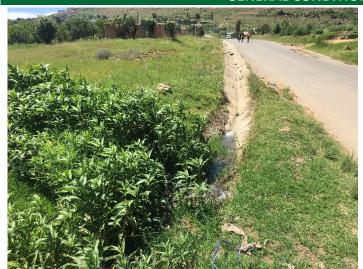
Figure 3: Existing Storm water infrastructure adjacent to the tarred road that is currently not maintained. (Direction - SE)

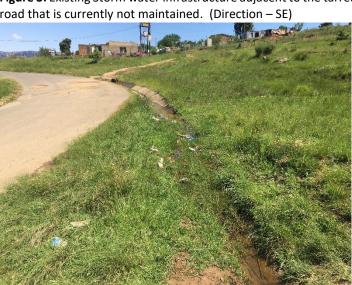
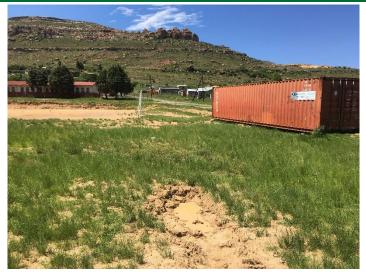
Figure 5: Existing and degraded Storm water infrastructure with Figure 6: The Metsi Matsho Tributary degraded by Illegal dumping overgrown vegetation (viewed from the south)

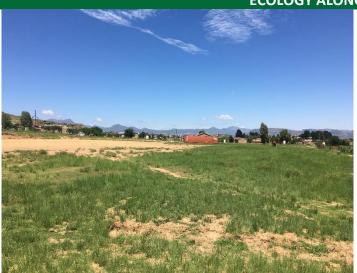
Figure 7: Overview of study site largely transformed and degraded

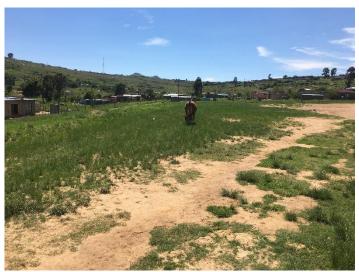
Figure 9: An example livestock grazing around the proposed site Figure 10: An oxpecker observed lingering around the cow was noted

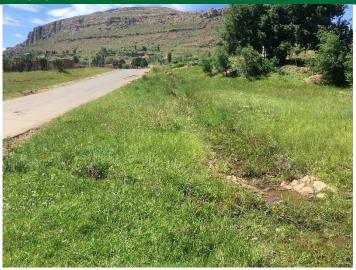
Figure 8: Remaining vegetation along the proposed discharge pipeline route

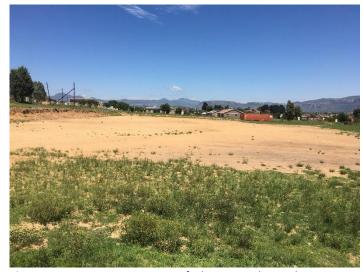
Figure 11: An interior view of the site where the proposed Healthcare facility (Clinic) is proposed

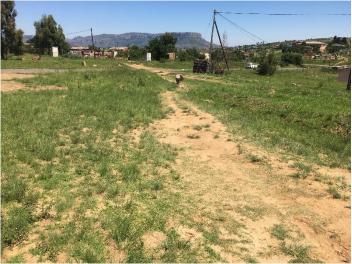
Figure 12: Surrounding transformed areas on the vicinity of the study area

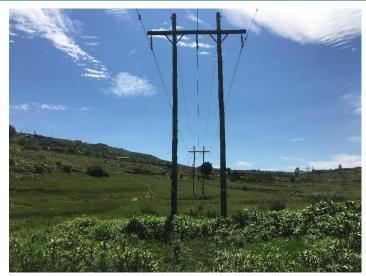
Figure 13: An example of existing electricity powerlines in n close proximity to the site

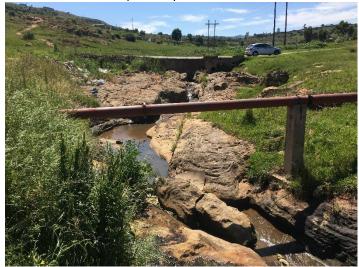
Figure 16: Water pipelines crossing the Metsi Matsho Tributary

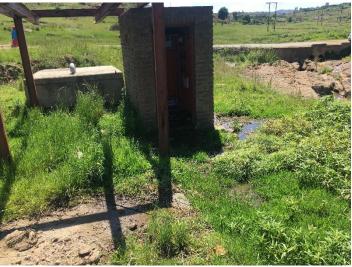
**Figure 14:** Dilapidated sewage pump station noted to be seeping raw sewage directly into the Metsi Matsho tributary

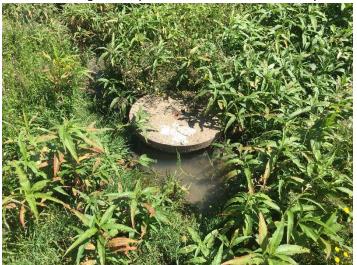
Figure 17: Manholes noted around site seeping sewage directly into the tributary
