PROJECT NRA R.101-080-2019/1

THE IMPROVEMENT OF NATIONAL ROAD
R101 SECTION 8 FROM BELA BELA (KM 0.0) TO
MODIMOLLE (KM 26.8)

FINAL PRELIMINARY DESIGN REPORT

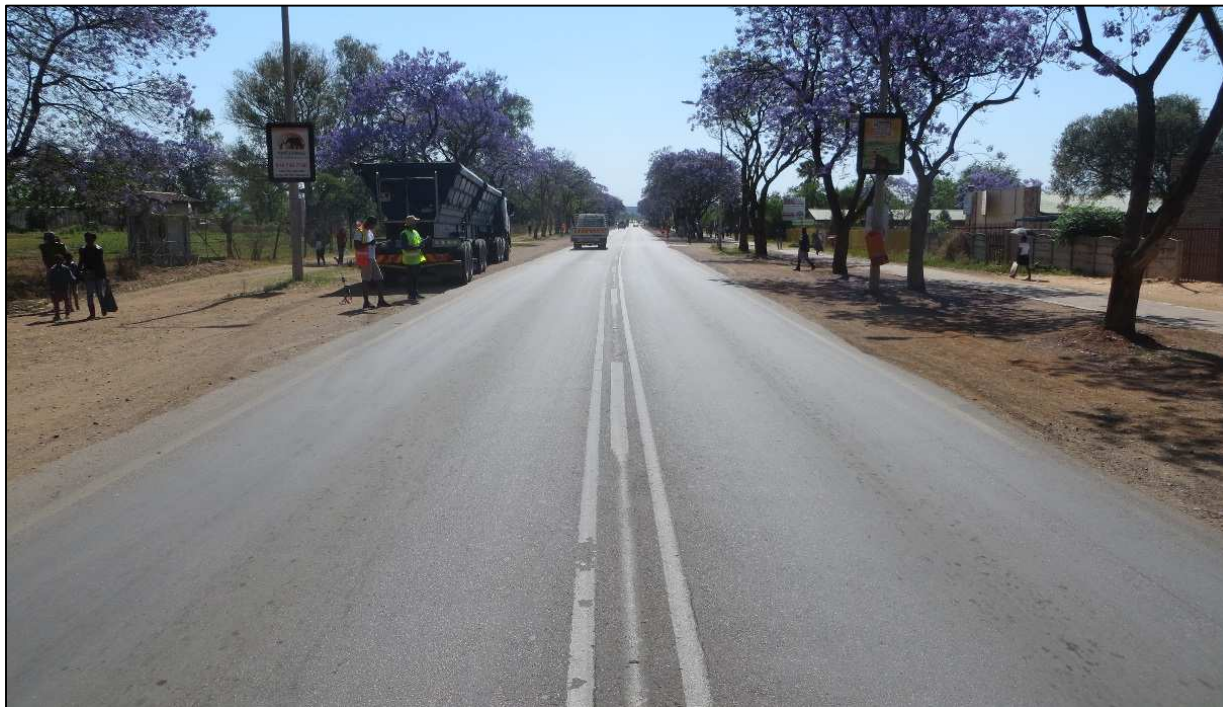
Photo 7.1: Typical appearance of first section at km 0.20

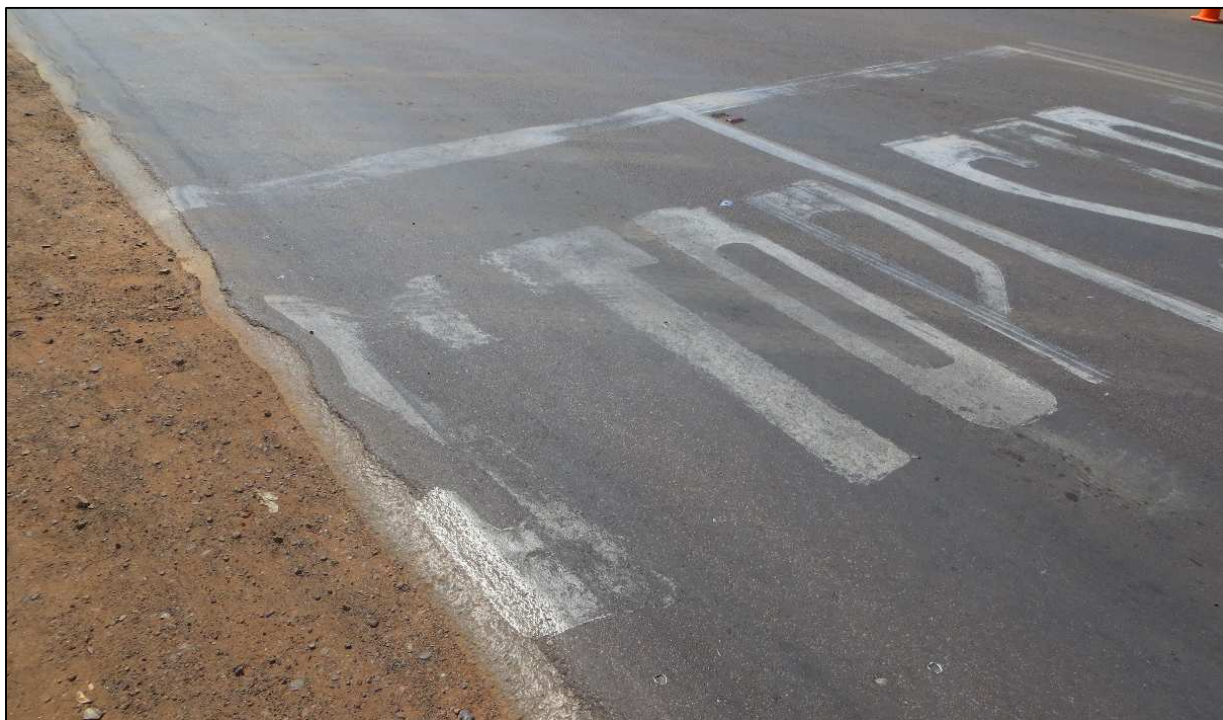
Photo 7.2: Shoving at Mile Street intersection (km 0.70)

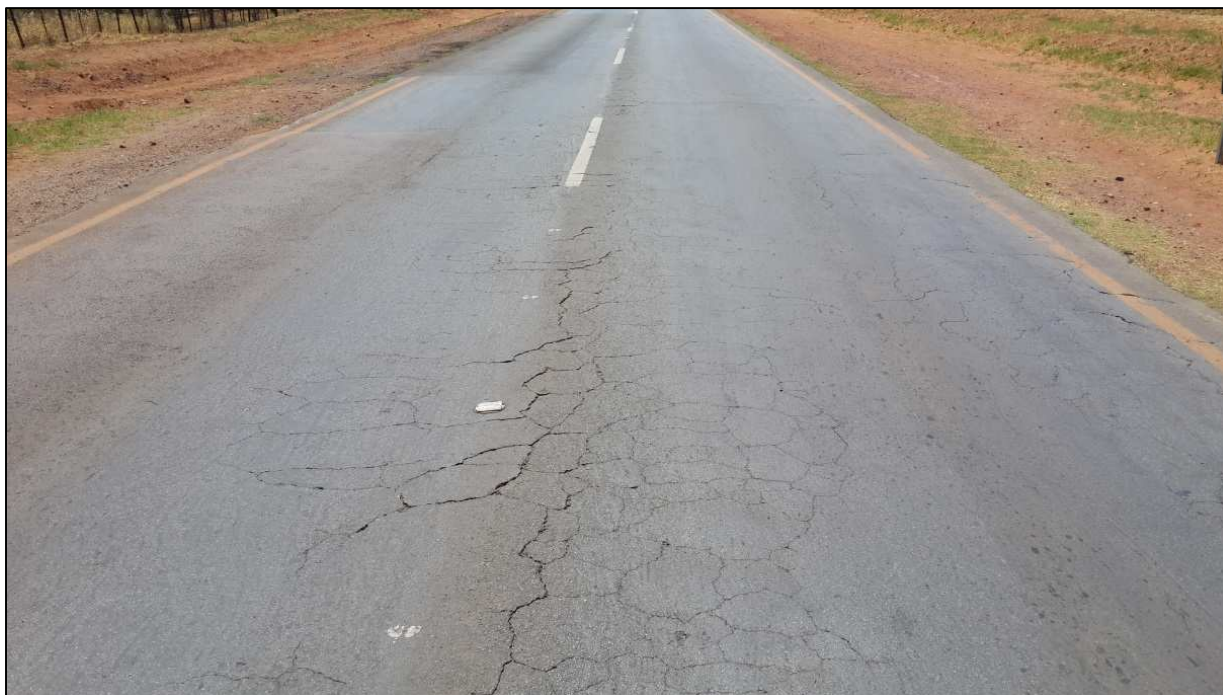
Photo 7.3: Rutting and typical appearance of the second section at km 4.60

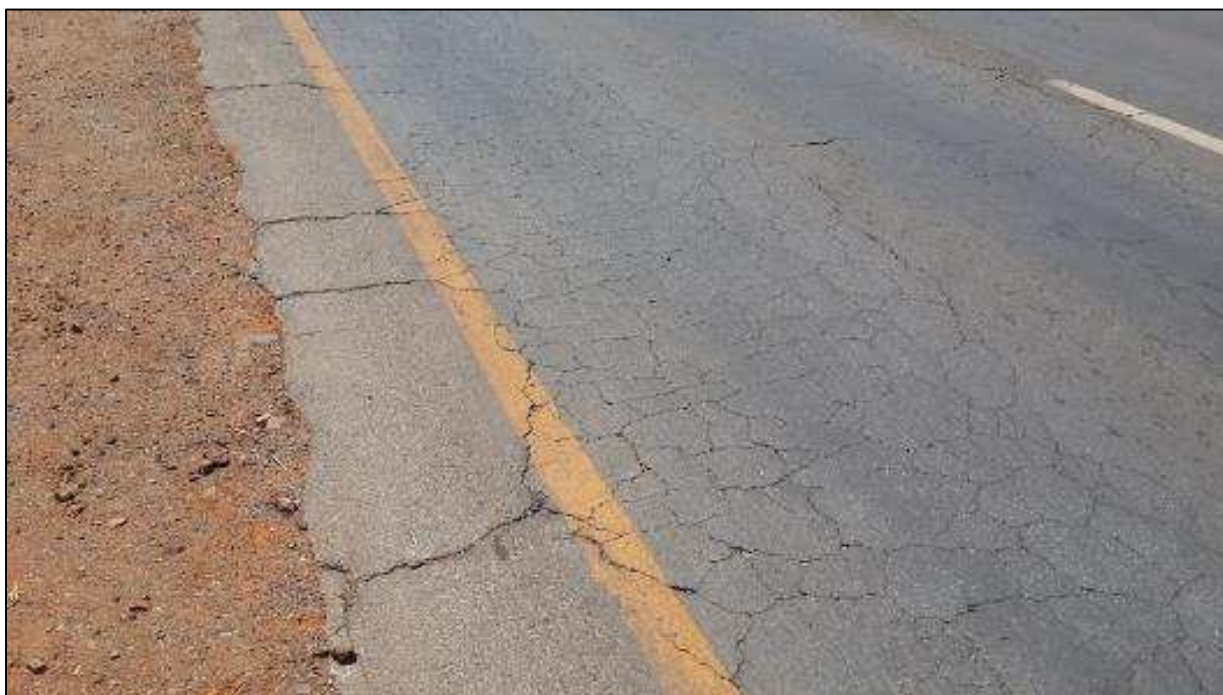
Photo 7.4: Typical crocodile cracks along the second section at km 4.00

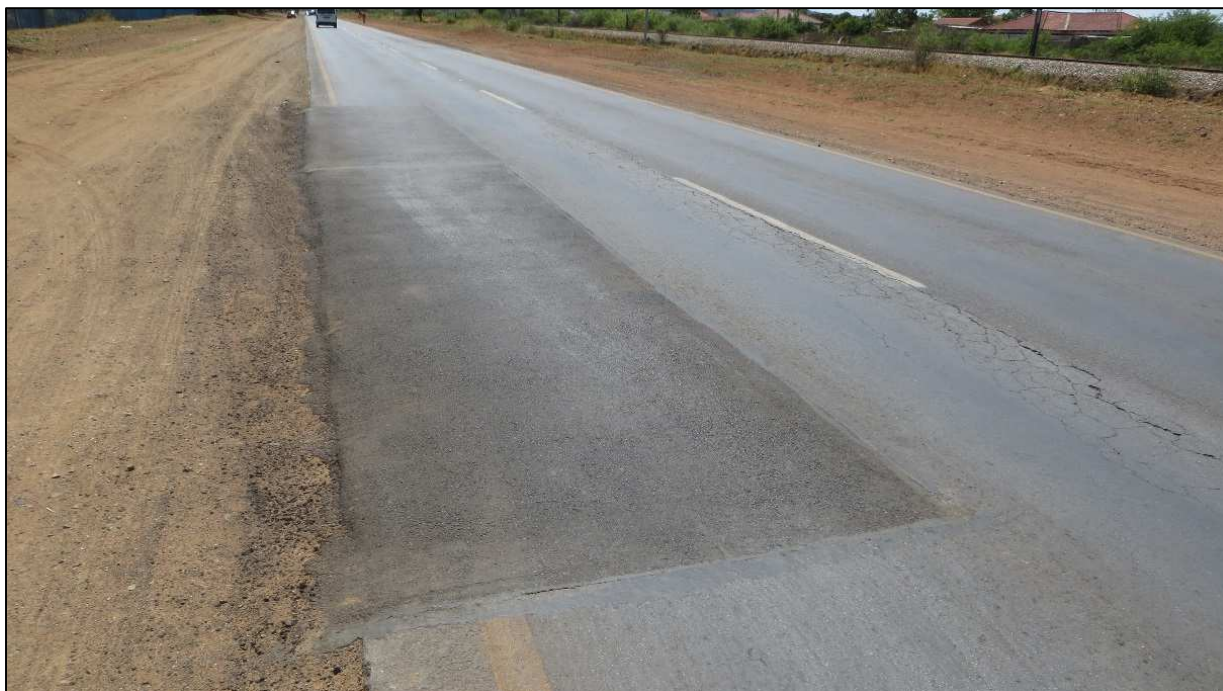
Photo 7.5: Patch, rut and crocodile cracks at km 2.40

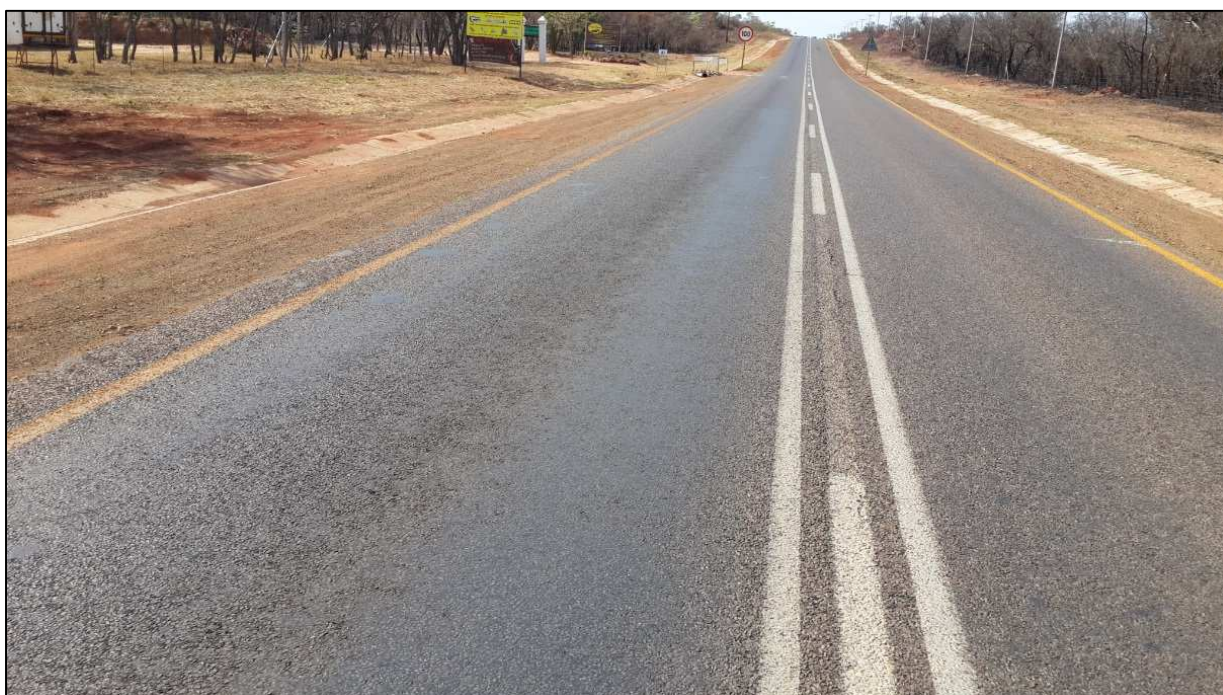
Photo 7.6: General appearance of section from km 5.44 to km 25.05 with flushing

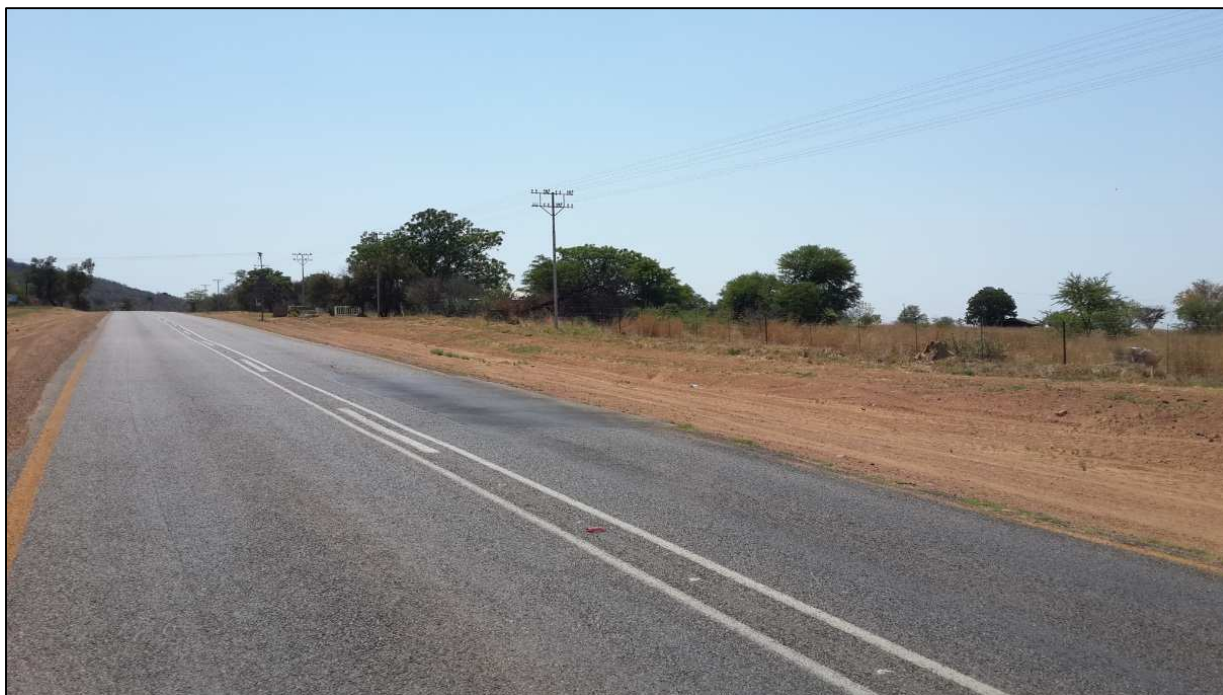
Photo 7.7: Undulation at km 18.20

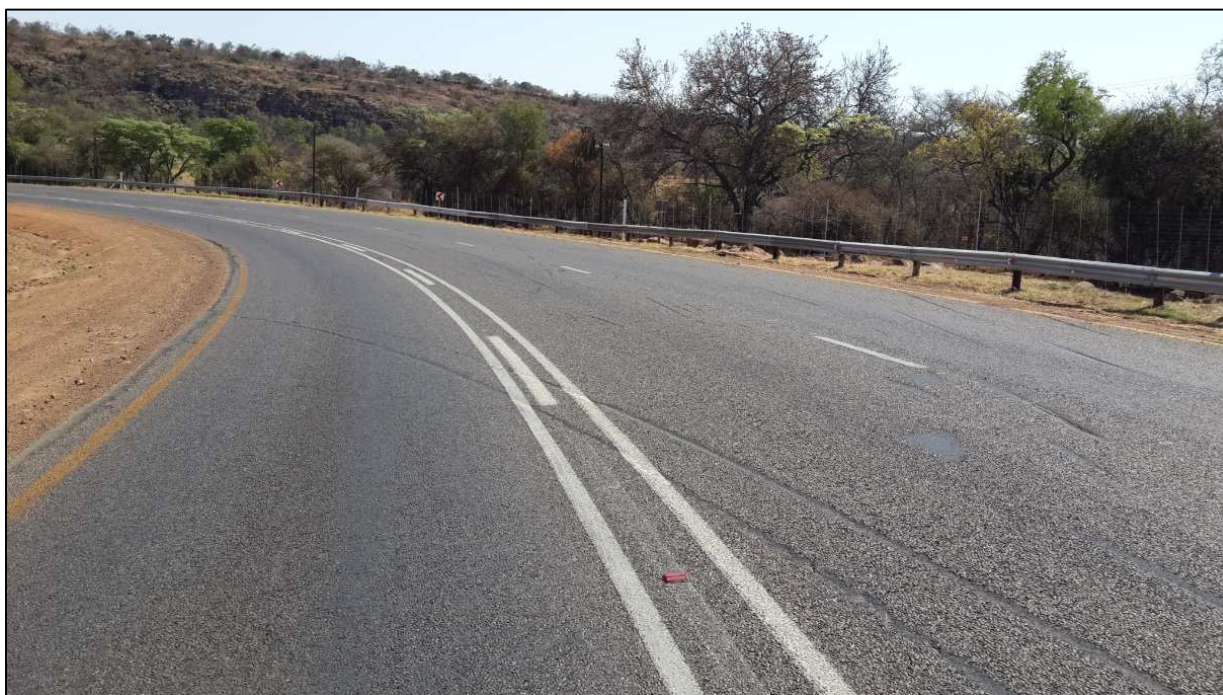
Photo 7.8: Mechanical damage on the curve at km 15.40

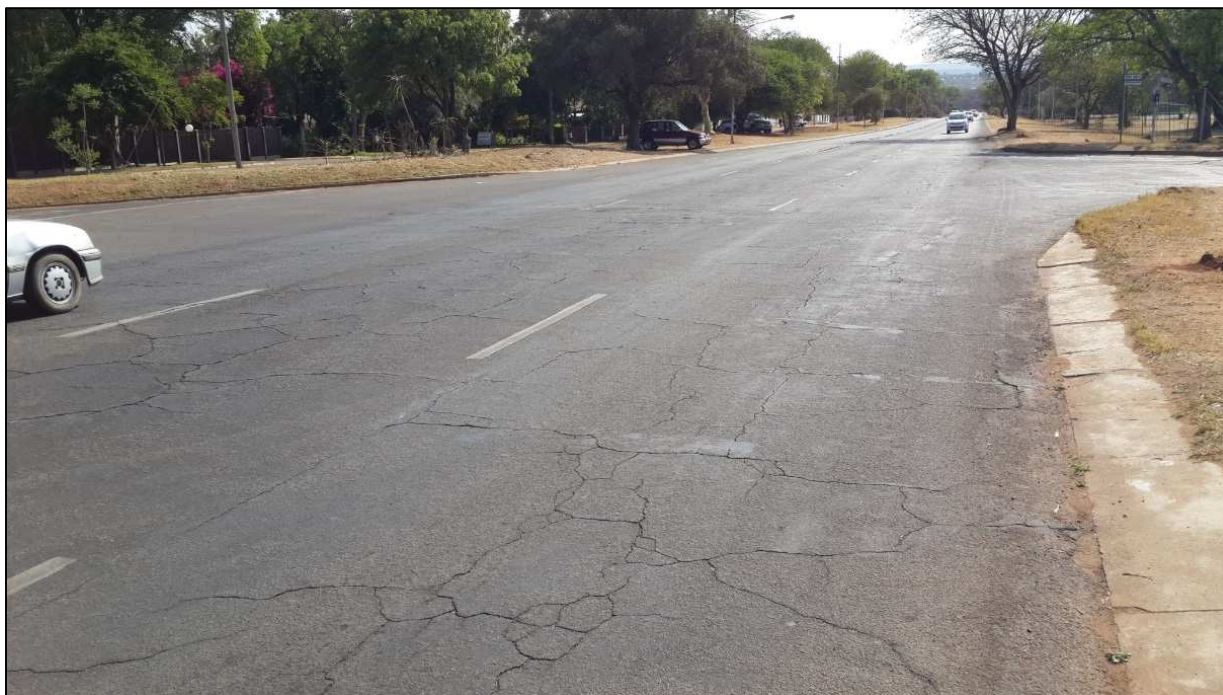
Photo 7.9: Typical appearance of section in Modimolle showing block and surface cracks

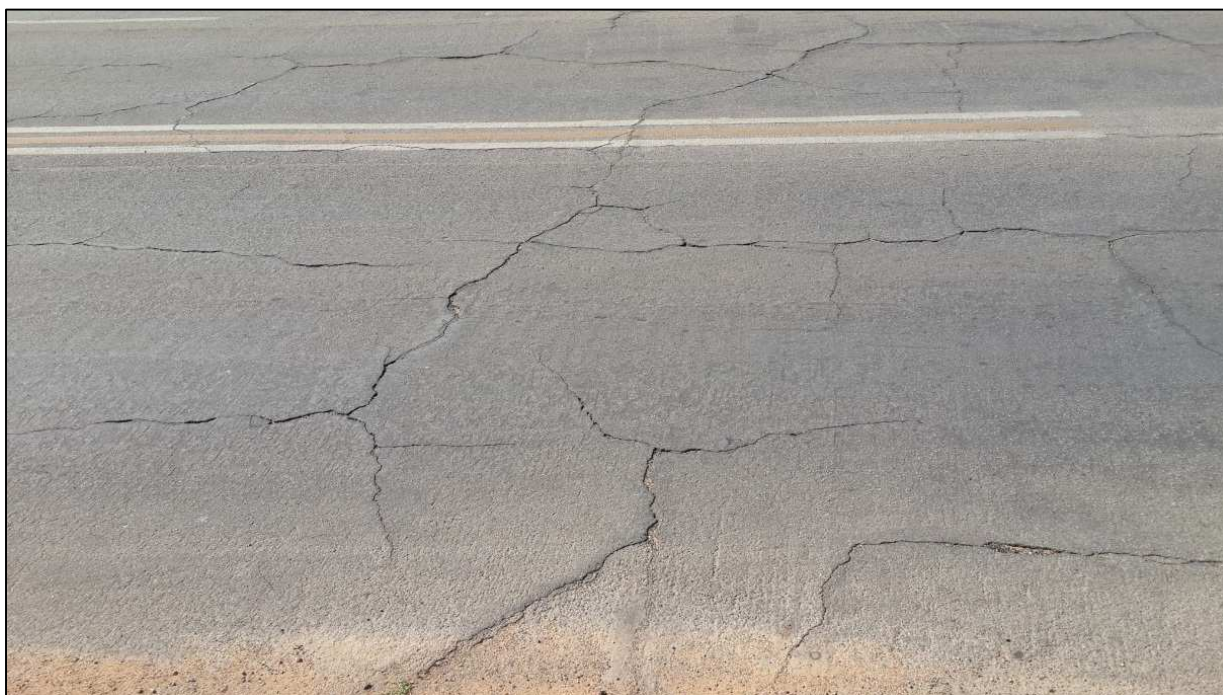
Photo 7.10: Block cracks from km 25.10 to km 26.80

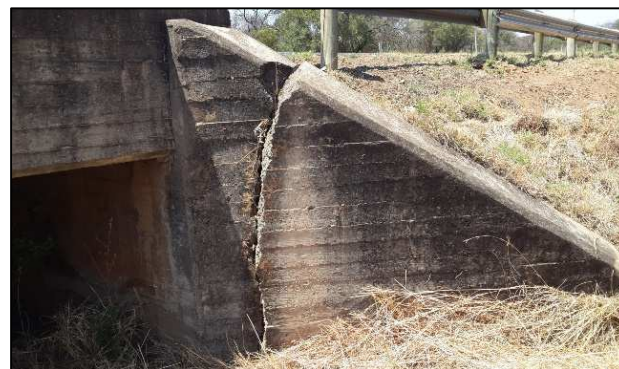
Figure 11.11: Cracked through wing wall

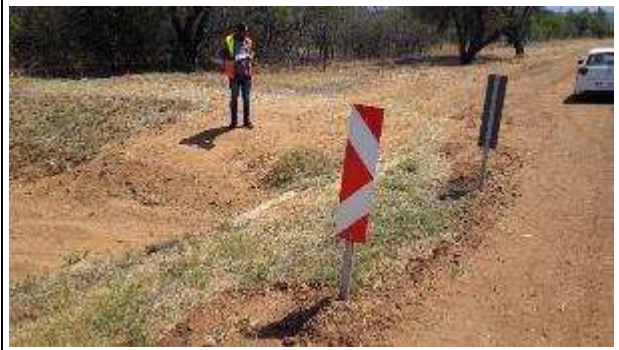
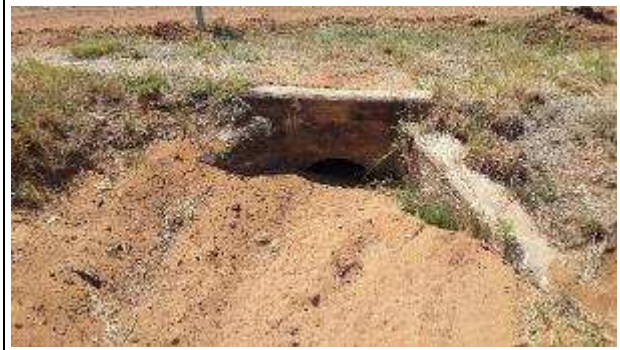
<p>Blocked Ø unknown Pipe culvert @ km 16.000</p>	<p>Blocked Ø unknown Pipe culvert @ km 16.000</p>

Figure 12.1: Blocked inlet and outlet structures due to reshaping of road prism

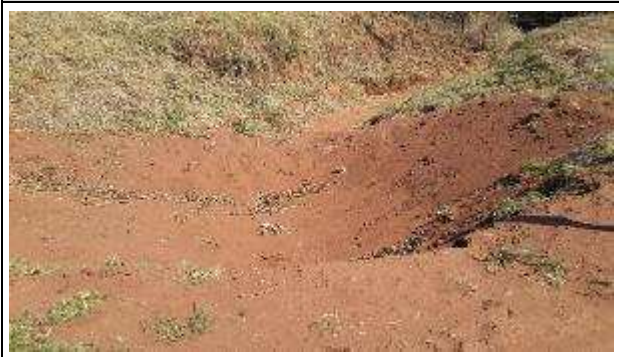
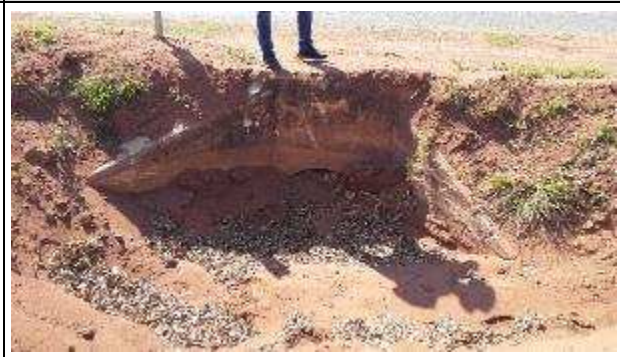
<p>Blocked Ø 600 Pipe culvert @ km 14.150</p>	<p>Blocked Ø 600 Pipe culvert @ km 14.150</p>

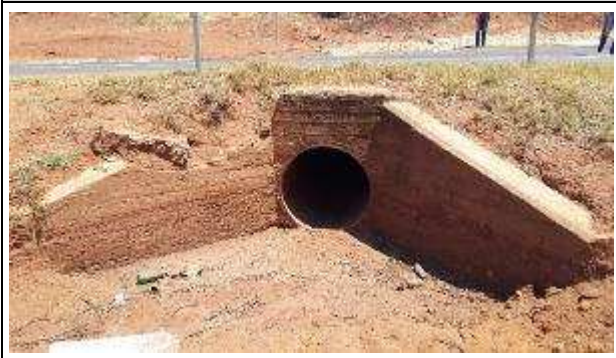
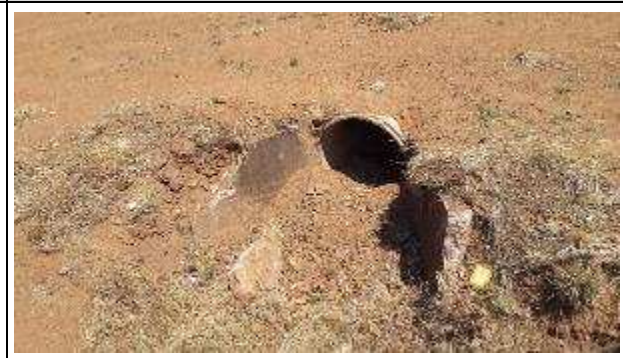
<p>Broken head wall for a Ø 600 Pipe culvert @ km 21.850</p>	<p>Demolished head wall for Ø 600 Pipe culvert @ km 21.850</p>

Figure 12.2: Typical head wall and wing wall defects

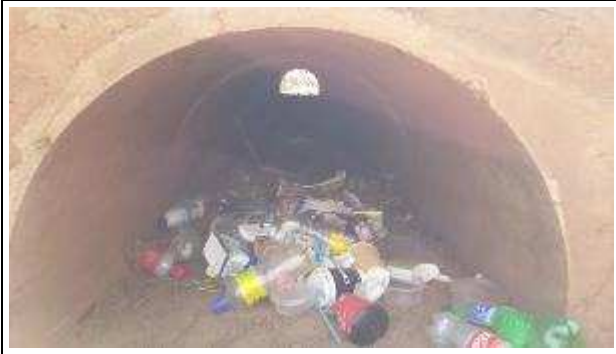
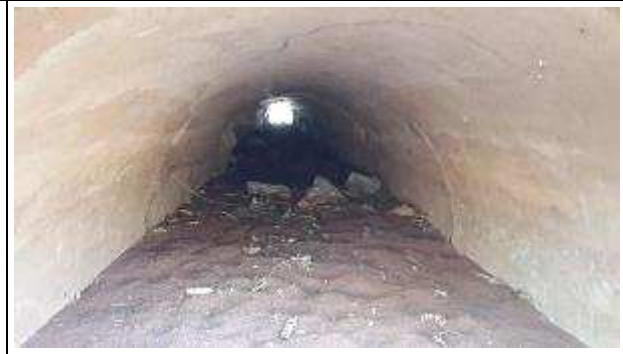
<p>Silted Ø 900 pipe culvert with debris @ km 16.400</p>	<p>Half silted Ø 900 pipe culvert @ km 14.150</p>

Figure 12.3: Blocked and misaligned pipe culvert barrels.

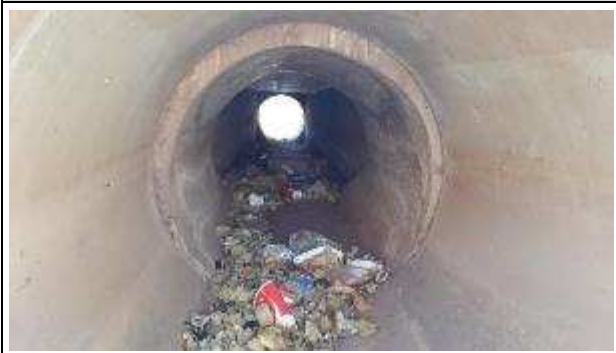
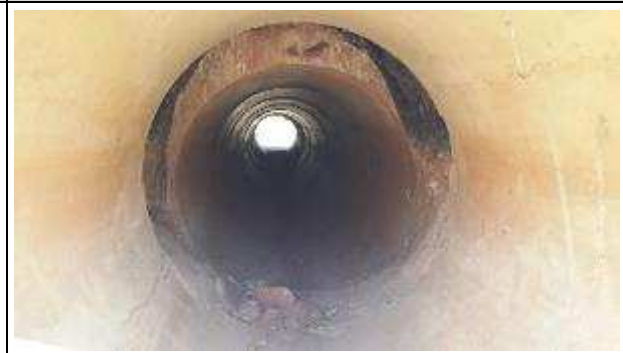
<p>Ø 900 Pipe culvert @ km 21.850</p>	<p>Misaligned Ø 600 Pipe culvert @ km 13.900</p>
