FRESHWATER ASSESSMENT

WATERCOURSE DELINEATION AND IMPACT ASSESSMENT OF THE PROPOSED REHABILITATION OF THE EXISTING BENMORE DAM WITHIN BENMORE GARDENS, GAUTENG PROVINCE

PREPARED FOR:	GA ENVIRONMENT (PTY) LTD.
PREPARED BY:	Environmental Assurance (Pty) Ltd.
SUBMITTED TO:	Nyaladzi Nleya
EMAIL:	Nyaladzin@gaenvironment.com
DATE:	02-07-2020
REPORT NUMBER:	SPS-REP-043-20_21
VERSION:	0.0

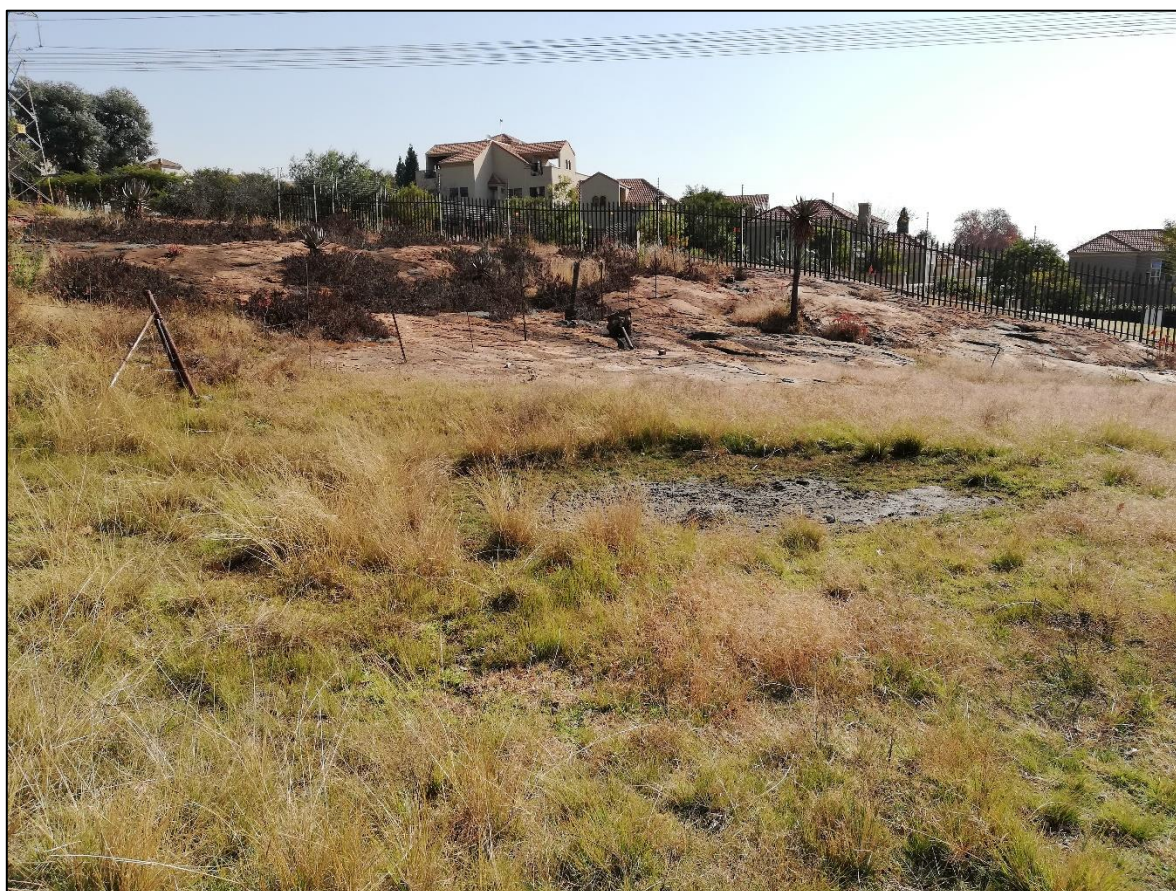
Figure 9: Evidence of exposed Halfway House Granite in the north western corner of the study area.

The unit consists of granodiorite (porphyritic in places), gneiss and migmatite (Council for Geoscience, 2008). The abovementioned lithostratigraphic unit can be described as a moderate-to-highly impermeable underlying sequence, which was observed to have been very shallow in the north western portion of the study area where sections of the dome are exposed (**Figure 9**). This geological formation is paramount to the subsurface seepage that was evident on either valley flowing into the central riverine system present within the study area. Precipitation presumably flows down the exposed sections of the dome into the B soil horizon, creating redoximorphic characteristics as the moisture precipitates the iron and manganese particles out of the soil prior to reaching the impermeable underlying sequence. The subsurface flow then flows downgradient and into the stream situated at the valley bottom, which was recorded to have been underlain by a sedimentary sequence (observed in the erosion donga formed).

Subsequent to a review of the hydrologic soil properties within the study area, it is evident that Class B soil formed the material overlying the abovementioned lithostratigraphic unit. Hydrological soil Class B generally demonstrates a moderate infiltration rate with rapid permeability and excessive to well-drained drainage (Schultze, 2010). These characteristics result in a moderate inherent surface runoff potential being exhibited by the soil profile. In terms of the slope characteristics, the well-drained, recharge, soils situated at the crest of the slope will result in plentiful flow entering the downstream watercourse via the soil/bedrock interflow toward the valley bottoms.

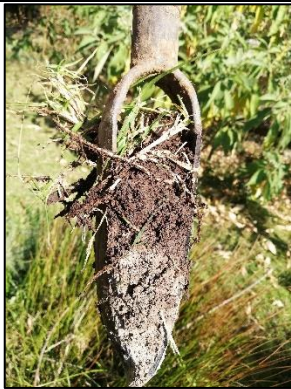
WETNESS ZONE	WETNESS INDICATORS	SOIL TEXTURE	MATRIX MUNSELL COLOUR CHART VALUES		IMAGE
			0-10CM	40-50CM	
Permanent	No permanently saturated soils were present within the study area. Alluvium was however sampled within the perennial stream channel.				
Seasonal	<ul style="list-style-type: none"> - >10% of matrix gleyed - High abundance of mottles - Frequently saturated 	Sandy clay loam	Hue: 10YR Value: 2 Chroma: 1-2	Hue: 10YR Value: 2 Chroma: 1-2

Table 14: Presentation of the soil wetness indicators recorded within each zone of wetness of the watercourses delineated within the study area, as well as an image and Munsell Colour Chart description of example soil samples.

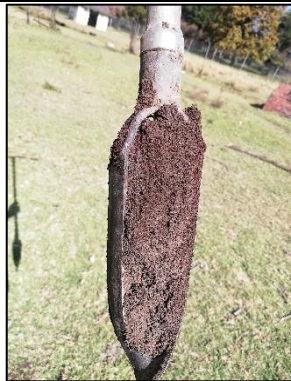
Temporary	<ul style="list-style-type: none"> - <10% of matrix gleyed - Moderate to low abundance of mottles - Saturated less than 3 months per annum 	Sandy Loam	Hue: 10YR Value: 4 Chroma: 1-3	Hue: 10YR Value: 4 Chroma: 1-2

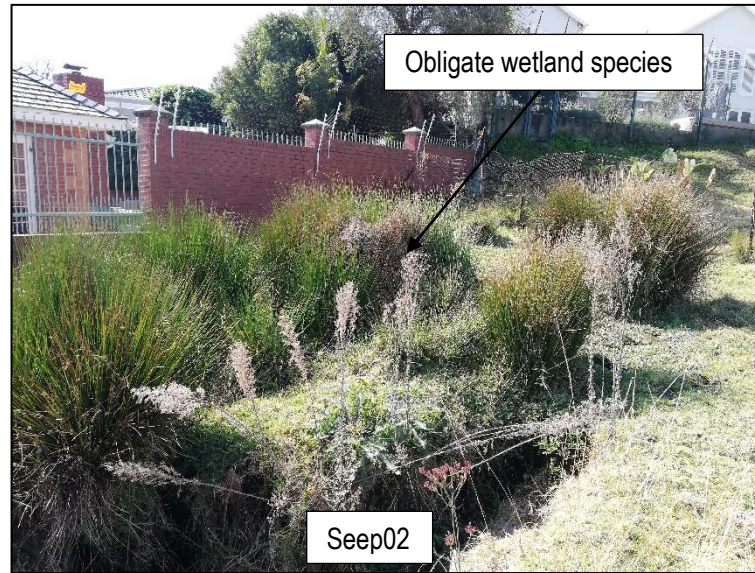
Figure 16: Illustrations of the onsite condition of the Hillslope Seepage wetland and evidence of their presence.

clearing/cutting within the upstream catchment area has also already the hydrological regime into the systems.
Geomorphology	Moderate gradient down slope with no erosion within the system. Cohesion of soil particles assisted by good groundcover and soils with a moderately high organic content.	Moderate to high gradient slopes with areas of slight erosion and hillslope slumping evident. Degradational systems with reduced soil particle cohesion. Infill events in sections impeding the flow of sediment downstream.
Vegetation	100 % native vegetation dominated by a mixture of obligate wetland plants, hydrophilic poaceae species and sparsely distributed woody vegetation.	Changes in land-use practices within the catchment areas (i.e. natural grassland to urban and gardens) have resulted in the encroachment of several IAPS (e.g. <i>Acacia mearnsii</i> , <i>Bidens pilosa</i> and <i>Solanum mauritianum</i>). Overgrazing directly within Seep01 and Seep02 has resulted in the systems being dominated by pioneer and ruderal weeds.

WET-HEALTH SCORES				
HGM UNIT	HYDROLOGY	GEOMORPHOLOGY	VEGETATION	OVERALL SCORE
Seep01	4.0 (D) ↓	3.1 (C) ↓	5.7 (D) ↓	4.2 (D) Largely Modified
Seep02	6.0 (E) ↓	4.6 (D) ↓	5.7 (D) ↓	5.5 (D) Largely Modified

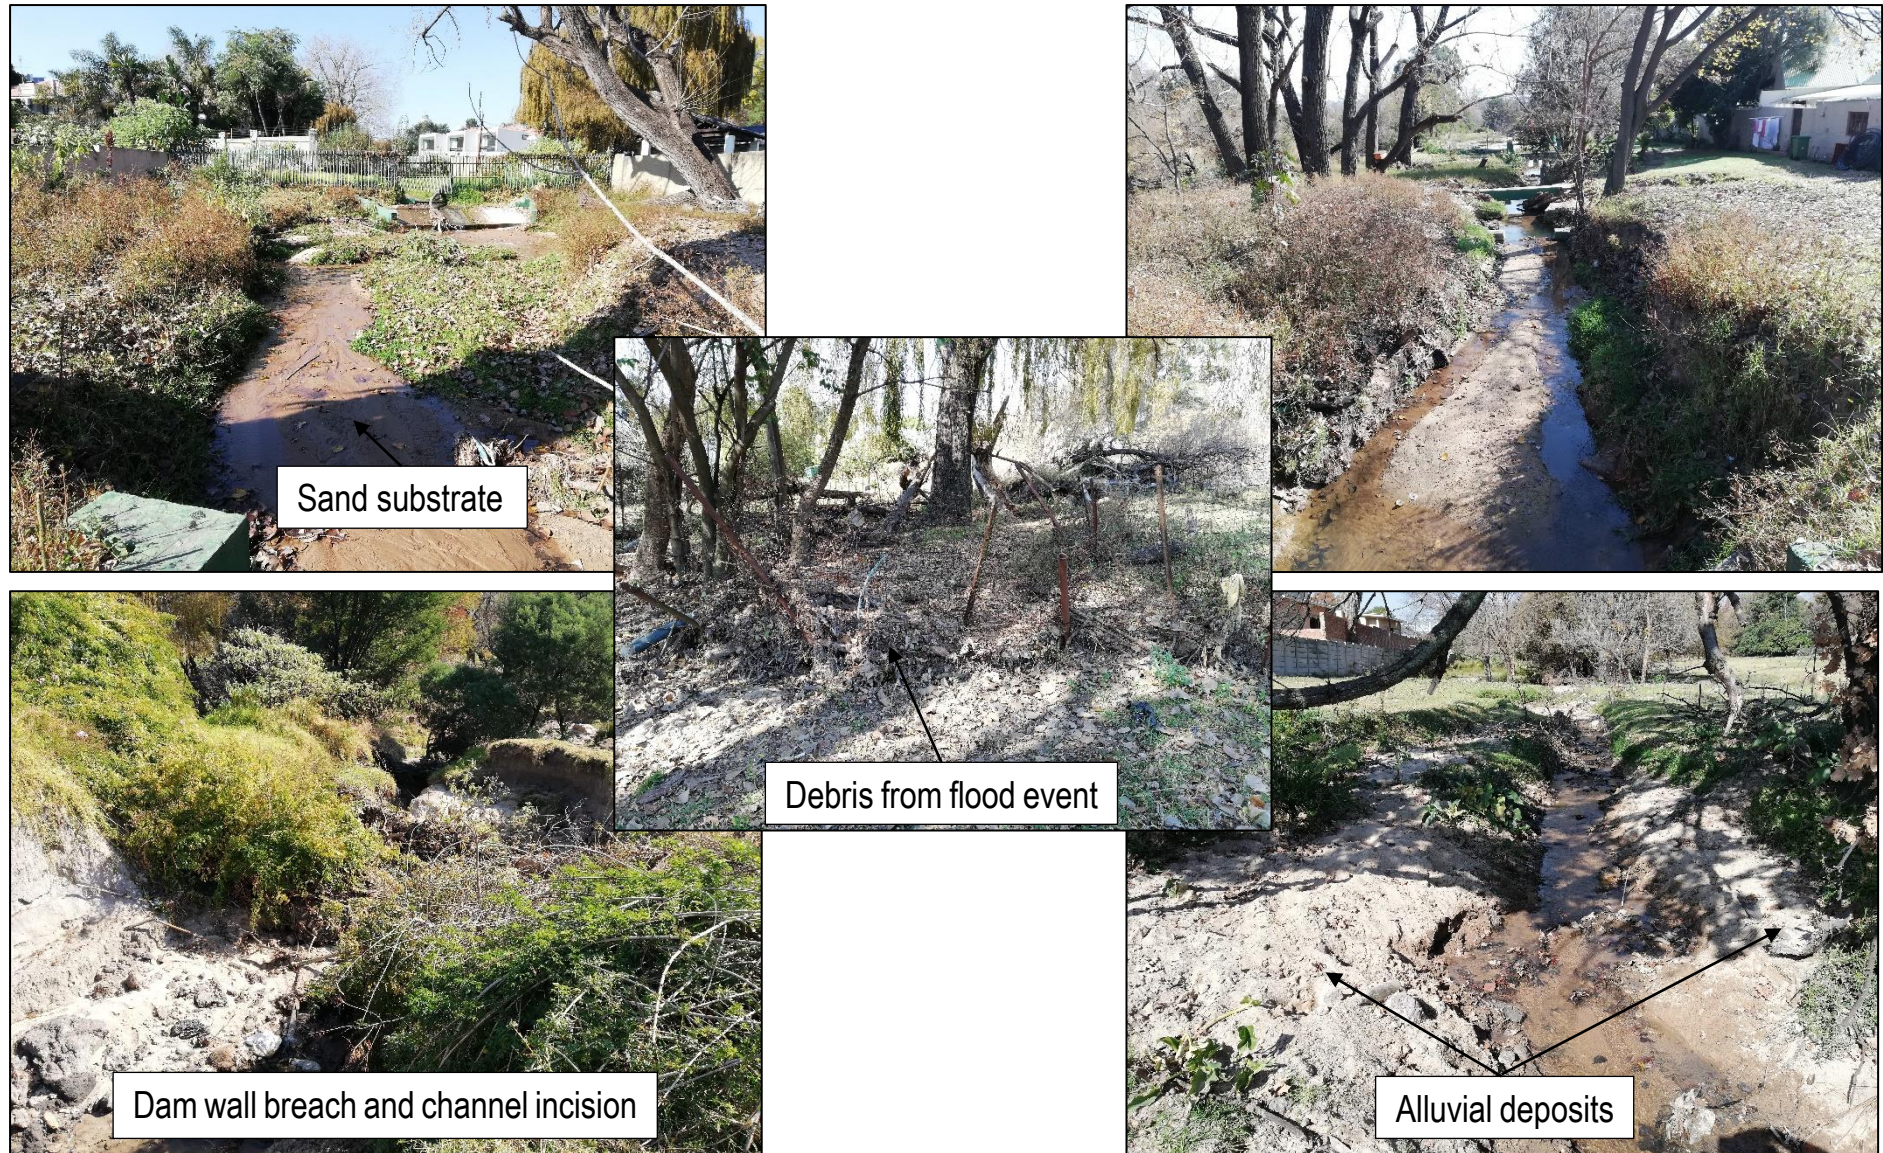
Figure 17: Illustration of the current condition of the Rip01 riverine system.

Riparian Habitat	The riparian zone of the Rip01 system was dominated by IAPS, namely; <i>Poplar deltoides</i> , <i>Salix babylonica</i> and <i>Acacia mearnsii</i> , that were presumably planted there for aesthetic purposes. Other IAPS that were recorded to have encroached into the zone were <i>Solanum mauritianum</i> , <i>Lantana camara</i> and <i>Canna indica</i> . A total of six (6) indigenous woody species were identified within the zone (ENVASS, 2020). The flood extent was recorded to be extensive towards the south of the site where the gradient levels, indicated by debris and alluvial deposits. These areas were included into the riparian zone, as per the DWAF (2008) delineation guideline. A small amount of fringe vegetation was available to be sampled using the SASS5 methodology, however these species were limited to cyperus and poaceae.

Figure 17 overleaf illustrates the general condition of the at-risk Rip01 riverine habitat that was assessed in-field during this study.

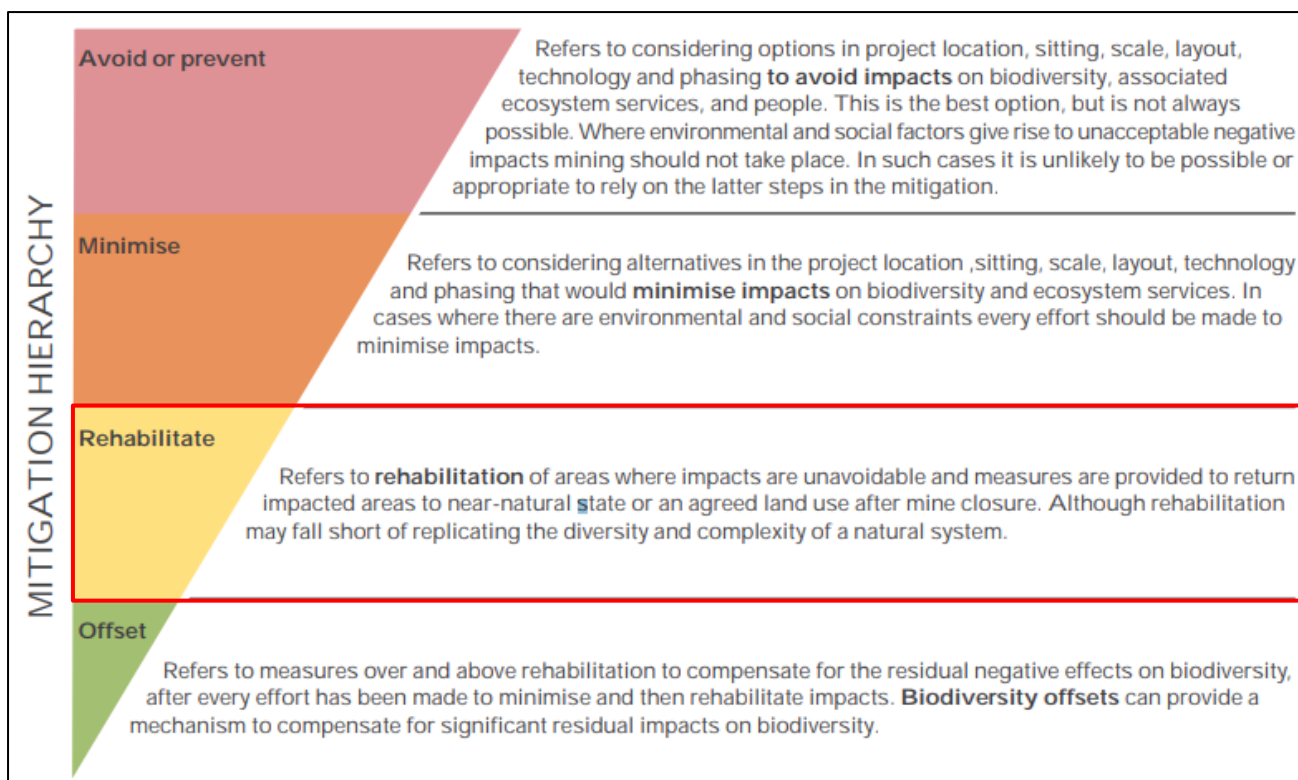
Figure 19: The mitigation hierarchy for dealing with negative impacts on biodiversity (DEA, 2013).
