FRESHWATER ASSESSMENT

WATERCOURSE DELINEATION AND IMPACT ASSESSMENT IN SUPPORT OF THE ENVIRONMENTAL AUTHORISATION AND WATER USE LICENSE APPLICATION PROCESS FOR THE PROPOSED UPGRADE OF THE EXISTING R101 ROAD BETWEEN MODIMOLLE AND BELA-BELA WITHIN THE LIMPOPO PROVINCE, SOUTH AFRICA

REPORT NUMBER: WET-REP-401-20 21

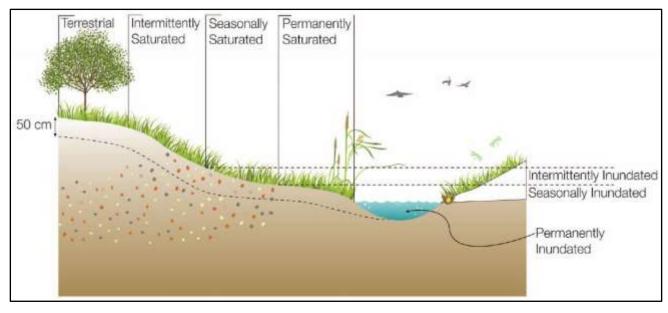
Figure 2: Illustration of the wetness zones typically present through a wetland system (Ollis et al., 2013).

The wetlands deemed to be at high or medium risk were delineated in detail during the field assessment utilising the methodology and techniques outlined within the wetland delineation manual 'A Practical Field Procedure for Identification and Delineation of Wetland and Riparian Areas' (DWAF, 2008). The permanent, seasonal and temporary (outer boundary) zones of wetness were determined by infield investigation of the wetness indicators, namely (**Figure 2**):

- 1. The Terrain Unit Indicator helps to identify those parts of the landscape where wetlands are more likely to occur.
- 2. The Soil Form Indicator identifies the soil forms, as defined by the Soil Classification Working Group (1991-2018), which are associated with prolonged and frequent saturation.
- 3. The Soil Wetness Indicator identifies the morphological "signatures" developed in the soil profile as a result of prolonged and frequent saturation.
- 4. The Vegetation Indicator identifies hydrophilic vegetation associated with frequently saturated soils.

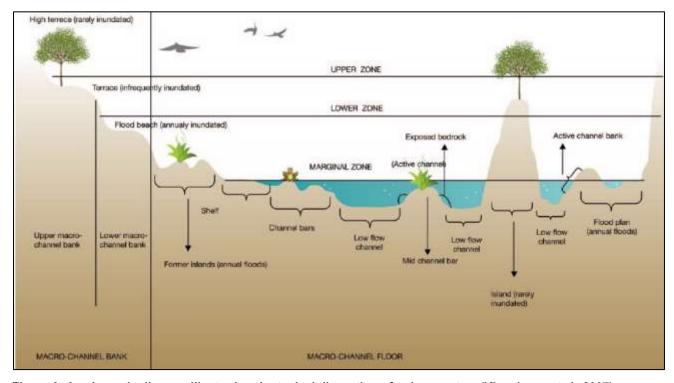
Figure 3: A schematic diagram illustrating the typical dissection of a river system (Kleynhans et al., 2007).

Additional verification can be obtained by examining for any recently alluvial deposited material to indicate the extent of flooding and thus obtain at least a minimum riparian zone width. The following procedure should be used for delineation of riparian zones: A good rough indicator of the outer edge of the riparian areas is the edge of the macro channel bank. This is defined as the outer bank of a compound channel, and should not be confused with the active river or stream channel bank. The macro-channel is an incised feature, created by uplift of the subcontinent which caused many rivers to cut down to the underlying geology and creating a sort of "restrictive floodplain" within which one or more active channels flow.

Floods seldom have any known influence outside of this incised feature. Within the macro-channel, flood benches may exist between the active channel and the top of the macro channel bank. These depositional features are often covered by alluvial deposits and may have riparian vegetation on them. Going (vertically) up the macro channel bank often represents a dramatic decrease in the frequency, duration and depth of flooding experienced, leading to a corresponding change in vegetation structure and composition.

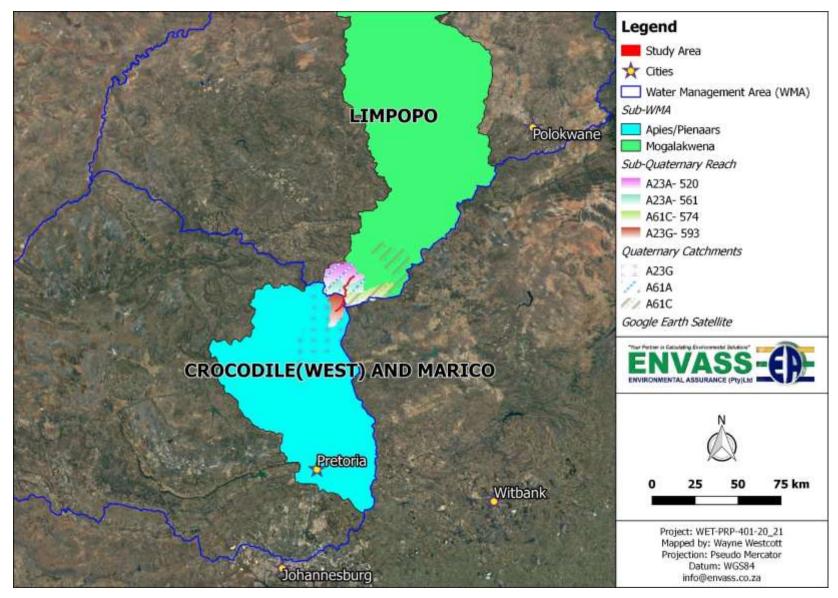
Figure 4: Illustration of the Water management Areas (WMAs), Sub Water Management Areas (SubWMAs) and Sub-Quaternary Reaches (SQR) associated with the study area (Kleynhans, 2005).

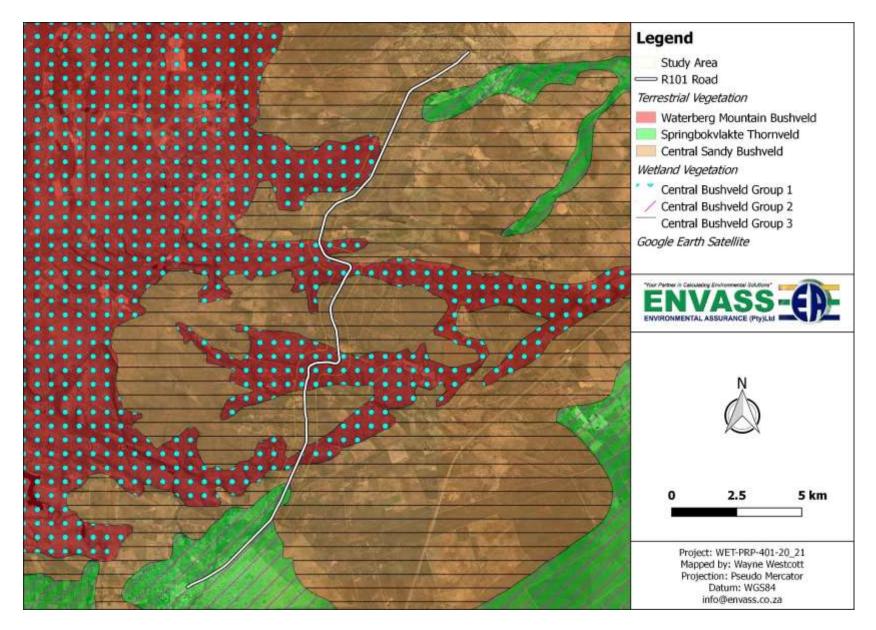
Figure 7: Terrestrial and wetland vegetation type associated with the study area (SANBI, 2006-2018 and Driver et al., 2011).

According to the most recent SANBI (2006-2018) delineation, the study area was recorded to extend through the following terrestrial vegetation units: Springbokvlakte Thornveld, Central Sandy Bushveld and Waterberg Mountain Bushveld (**Figure 7**). **Table 17** below presents the conservation information relative to the vegetation types. It must however be noted that the condition of the aforementioned vegetation types varied according to the degree to which the changing land-use practices within and surrounding the study area had encroached on the overall delineated boundaries, and thus this has altered the desktop delineated vegetation units.

Figure 7 below also presents the wetland vegetation (WetVeg) types that were delineated within the study area, at a national scale (Driver *et al.*, 2011). The WetVeg types that were observed within the study area included the Central Bushveld Group 1 (Critically Endangered), the Central Bushveld Group 2 (Vulnerable) and the Central Bushveld Group 3 (Endangered) (Driver *et al.*, 2011). Remnants of these WetVeg units were recorded on-site, however the majority of the watercourses had been invaded by Invasive and Alien Plant Species (IAPS) and pioneer species within the proposed disturbance footprints.

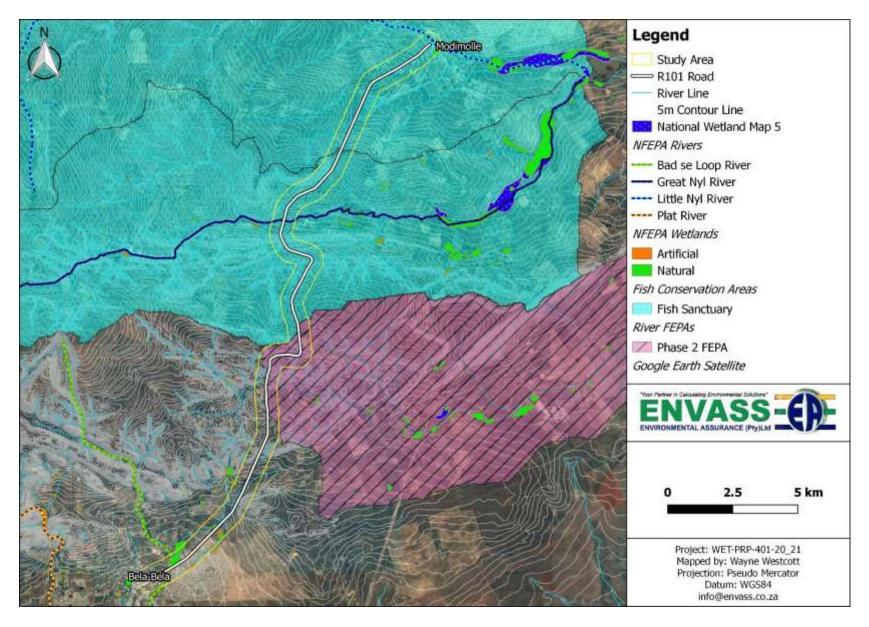
Figure 9: Illustration of the NFEPA and NWM5 systems that were recorded within and around the study area (Driver et al., 2011 and SANBI, 2018).

According to the NFEPA dataset, the northern portion of the proposed development will traverse a Fish Sanctuary; and a small portion of the centre of the proposed development will traverse a Phase 2 Freshwater Ecosystem Priority Area (FEPA) (Figure 9). Fish sanctuaries are rivers that are essential for protecting threatened freshwater fish that are indigenous to South Africa. The entire sub-quaternary catchment associated with the river is indicated as a Fish Sanctuary. There should be no further deterioration in river condition in fish sanctuaries and no new permits should be issued for stocking invasive alien fish in farm dams in the associated sub-catchment. Phase 2 FEPAs were identified in moderately modified rivers (C ecological category) and their associated sub-quaternary catchments, only in cases where it was not possible to meet biodiversity targets for river ecosystems in rivers that were still in good condition (A or B ecological category). The condition of these Phase 2 FEPAs should not be degraded further, as they may in future be considered for rehabilitation once FEPAs in good condition (A or B ecological category) are considered fully rehabilitated and well managed.

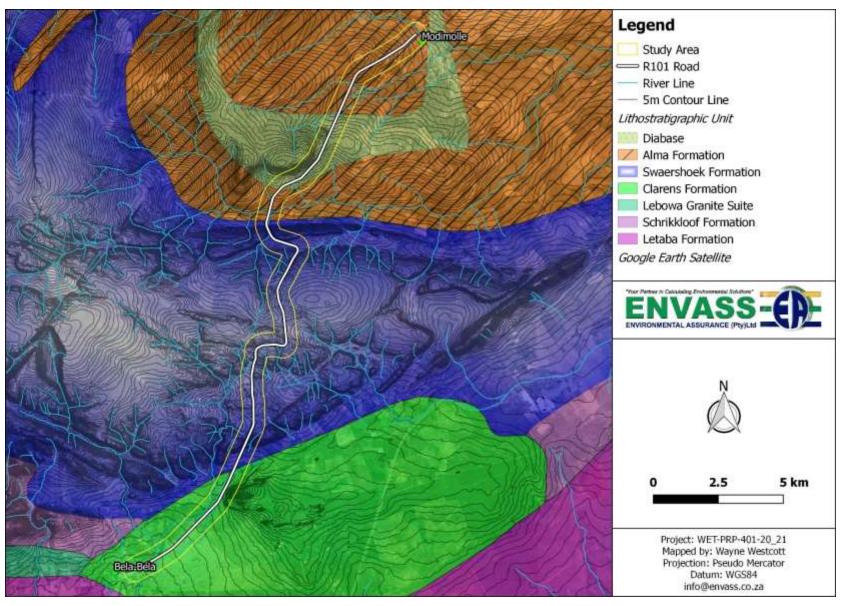
Figure 10: Geology recorded in the study area (Council for Geoscience, 2008).

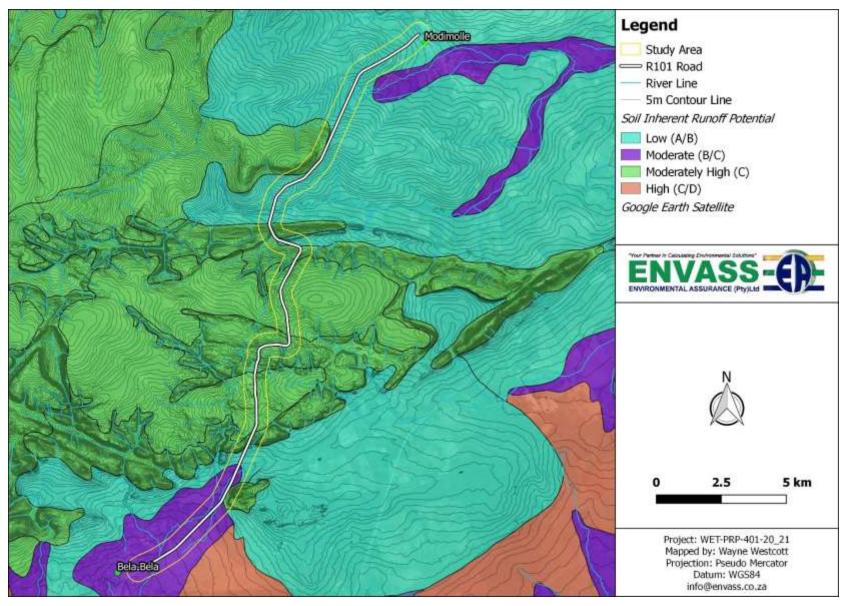
Figure 11: Soils recorded in the study area (Schultze et al., 1992).

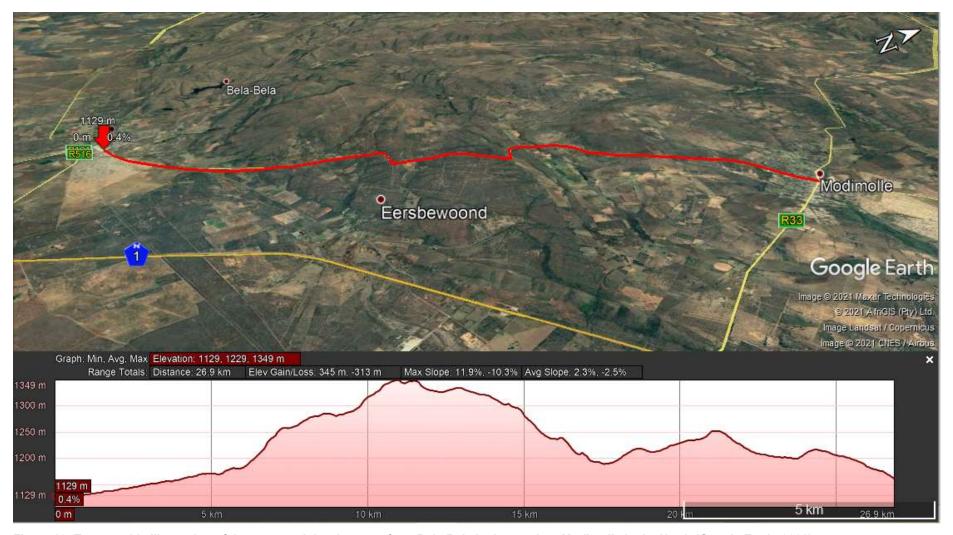
Figure 12: Topographic illustration of the proposed development from Bela-Bela in the south to Modimolle in the North (Google Earth, 2021).

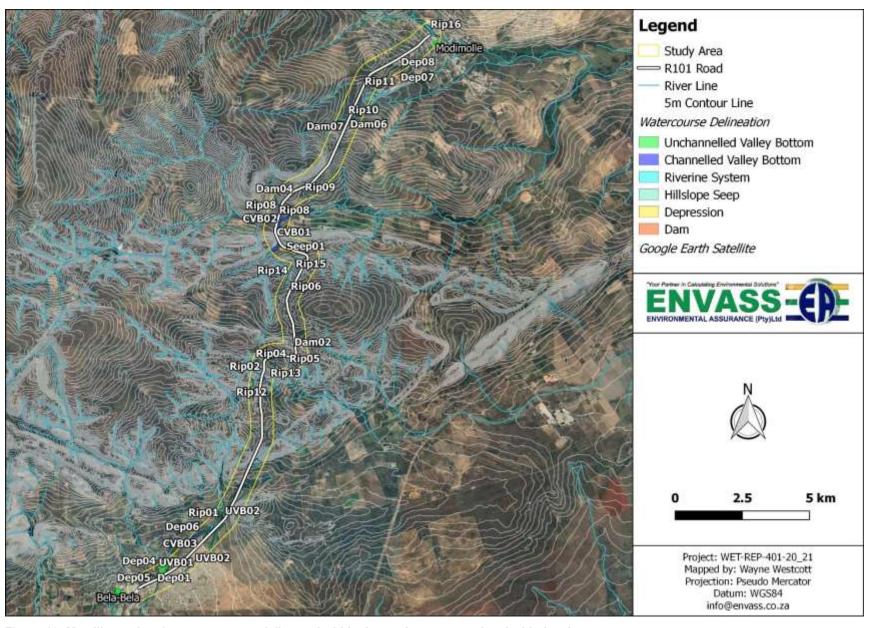
Figure 13: Map illustrating the watercourses delineated within the study area associated with the site.

The watercourses within the study area were identified on a desktop level, classified and delineated in-field and subsequently mapped utilising GIS (QGIS 2.18 and Google™ Earth Pro) and available spatial data (**Figure 13**). For ease of reference the study area was broken up into sections and presented in **Figures 13** to **17**, with **Figure 13** presenting the overall project delineation map.

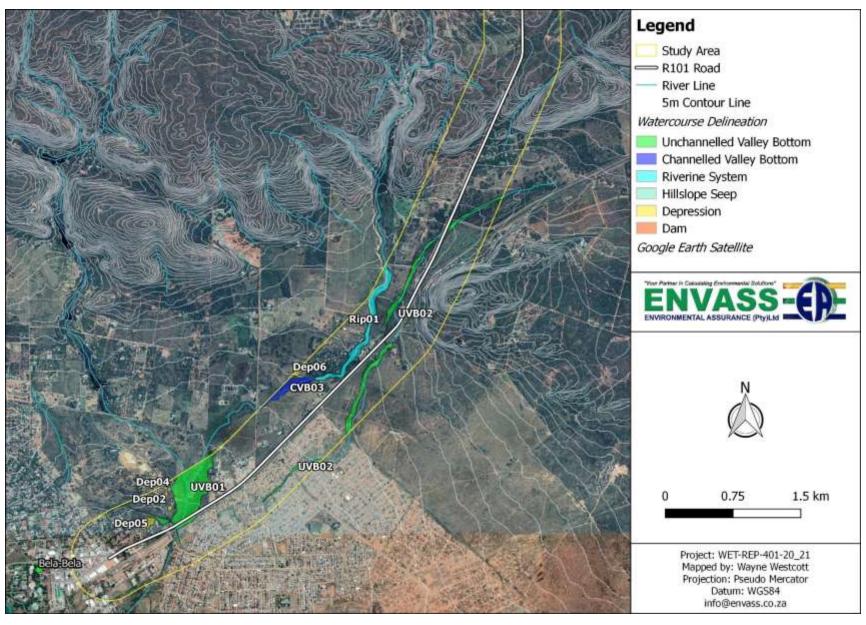
Figure 14: Map illustrating the delineated watercourses within the southern portion of the study area near Bela-Bela.

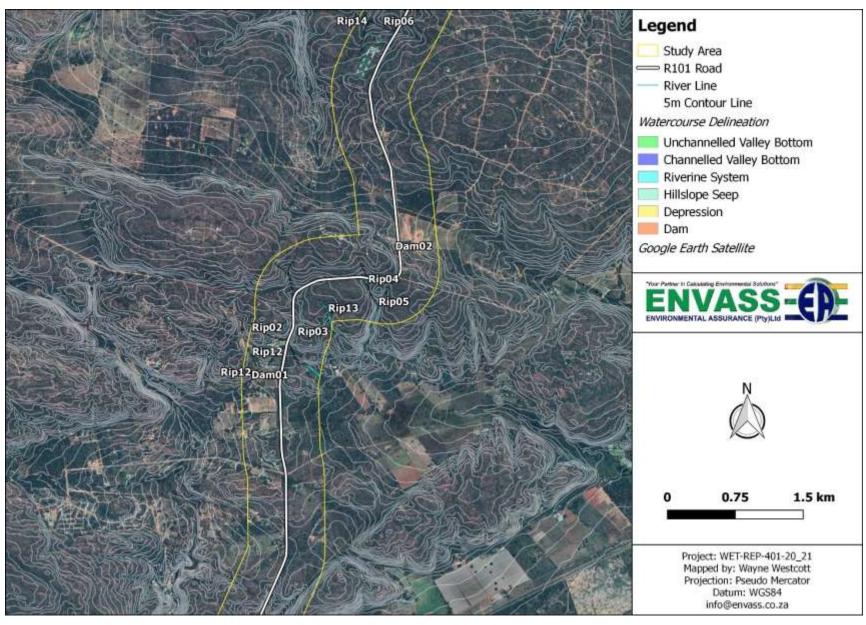
Figure 15: Map illustrating the delineated watercourses within the middle portion of the study area.

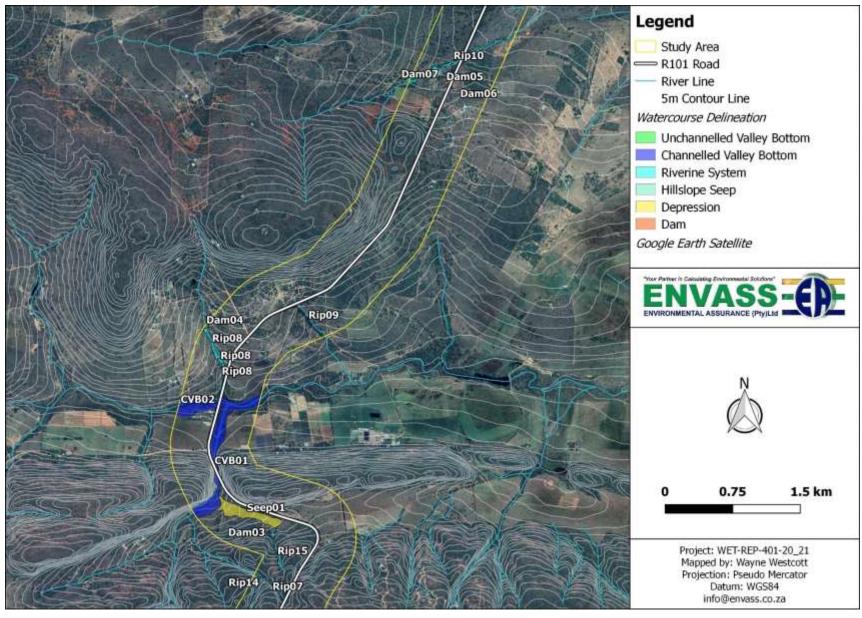
Figure 16: Illustration of the watercourses delineated within the middle portion of the study area near the Groot Nyl.

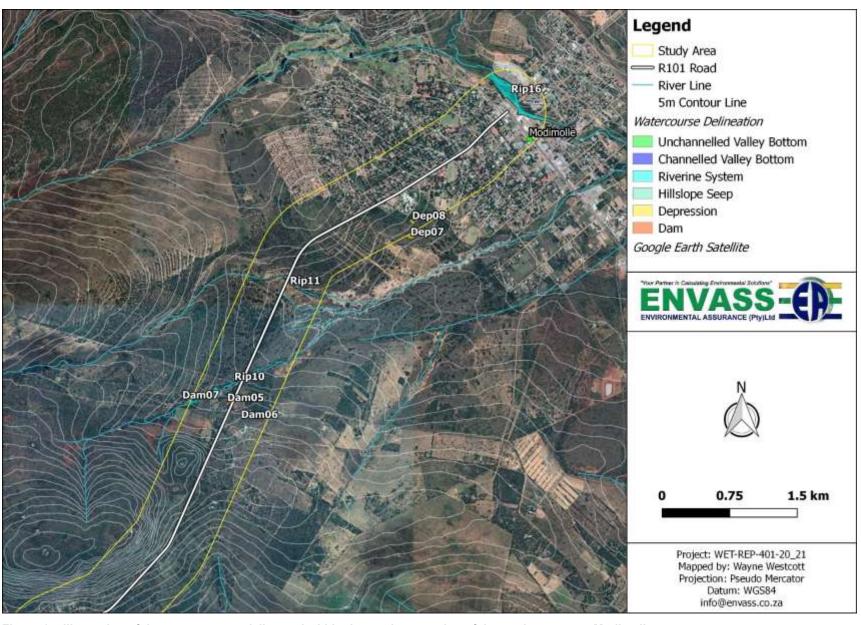
Figure 17: Illustration of the watercourses delineated within the northern portion of the study area near Modimolle.

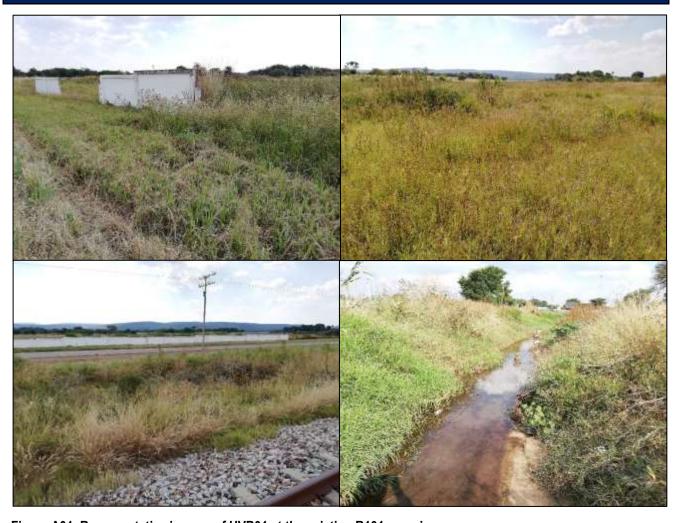
Figure A01. Representative images of UVB01 at the existing R101 crossing.

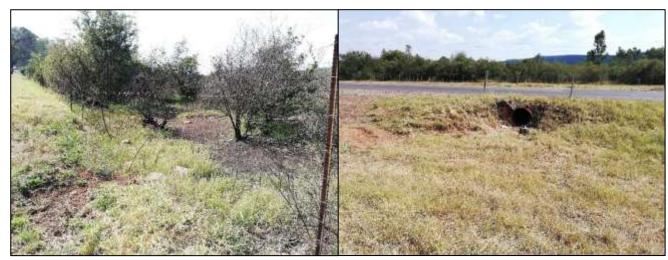
Figure A02. Representative images of UVB02 at the existing R101 crossing.

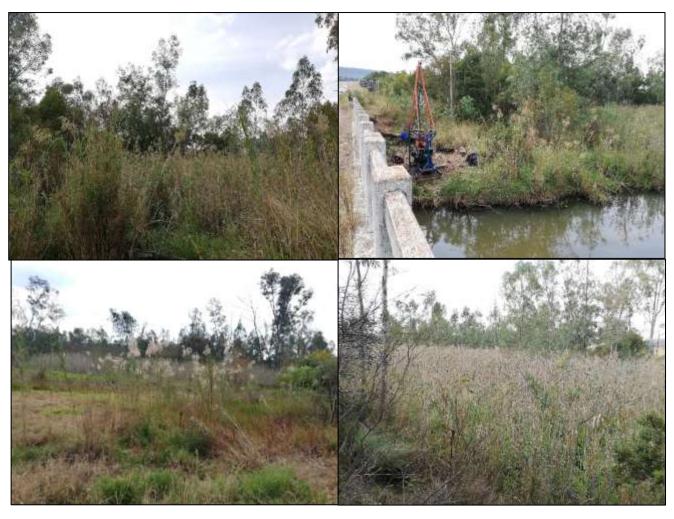
Figure A03. Representative images of CVB01 at the existing R101 crossing.

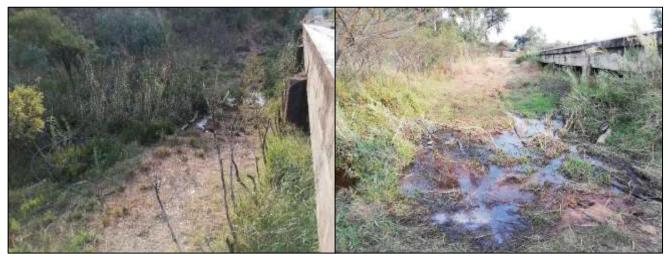
Figure A04. Representative images of CVB02 at the existing R101 crossing.

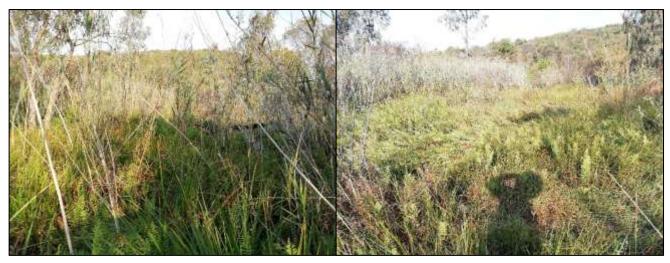
Figure A05. Representative images of portions of CVB02 located directly adjacent to the R101.

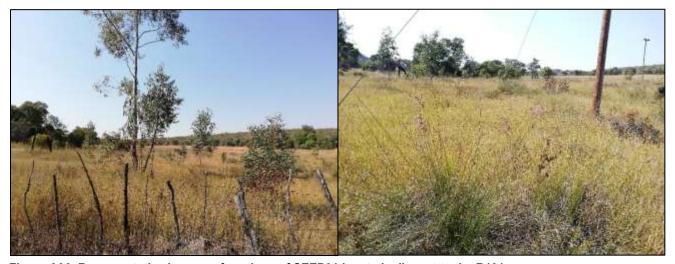
Figure A06. Representative images of portions of SEEP01 located adjacent to the R101.

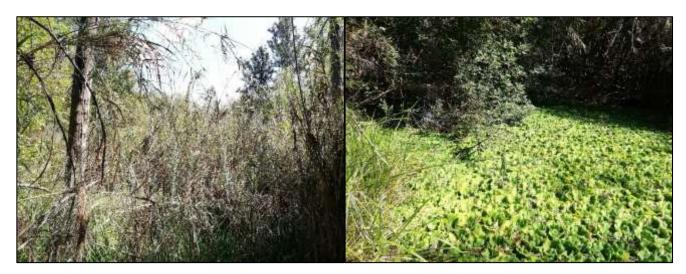
Figure A07. Representative images of portions of perennial Rip01 located adjacent to the R101.

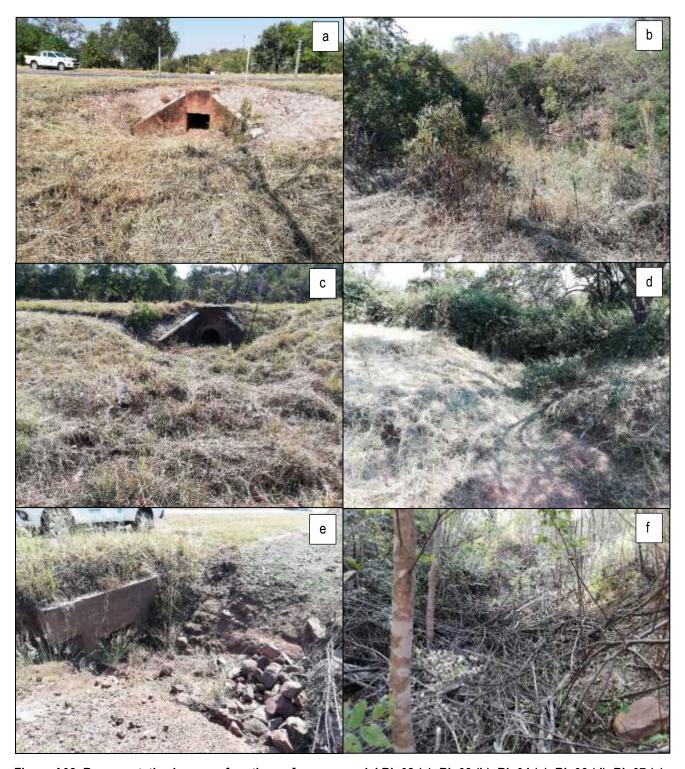
Figure A08. Representative images of portions of non-perennial Rip02 (a), Rip03 (b), Rip04 (c), Rip06 (d), Rip07 (e) and Rip08 (f) at existing R101 crossing points.

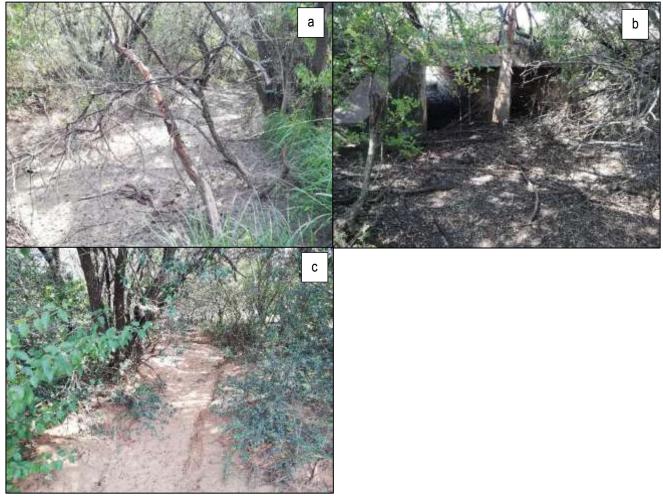
Figure A09. Representative images of portions of non-perennial Rip09 (a), Rip10 (b), and Rip11 (c) at existing R101 crossing points.
