REHABILITATION PLAN

**FOR THE PROPOSED UPGRADE OF NATIONAL ROAD R101 SECTION 8
FROM BELA BELA (KM 0.0) TO MODIMOLLE (KM 26.8),
WATERBERG DISTRICT MUNICIPALITY, LIMPOPO PROVINCE**

DFFE REFERENCE: 14/12/16/3/3/1/2354

AUGUST 2021

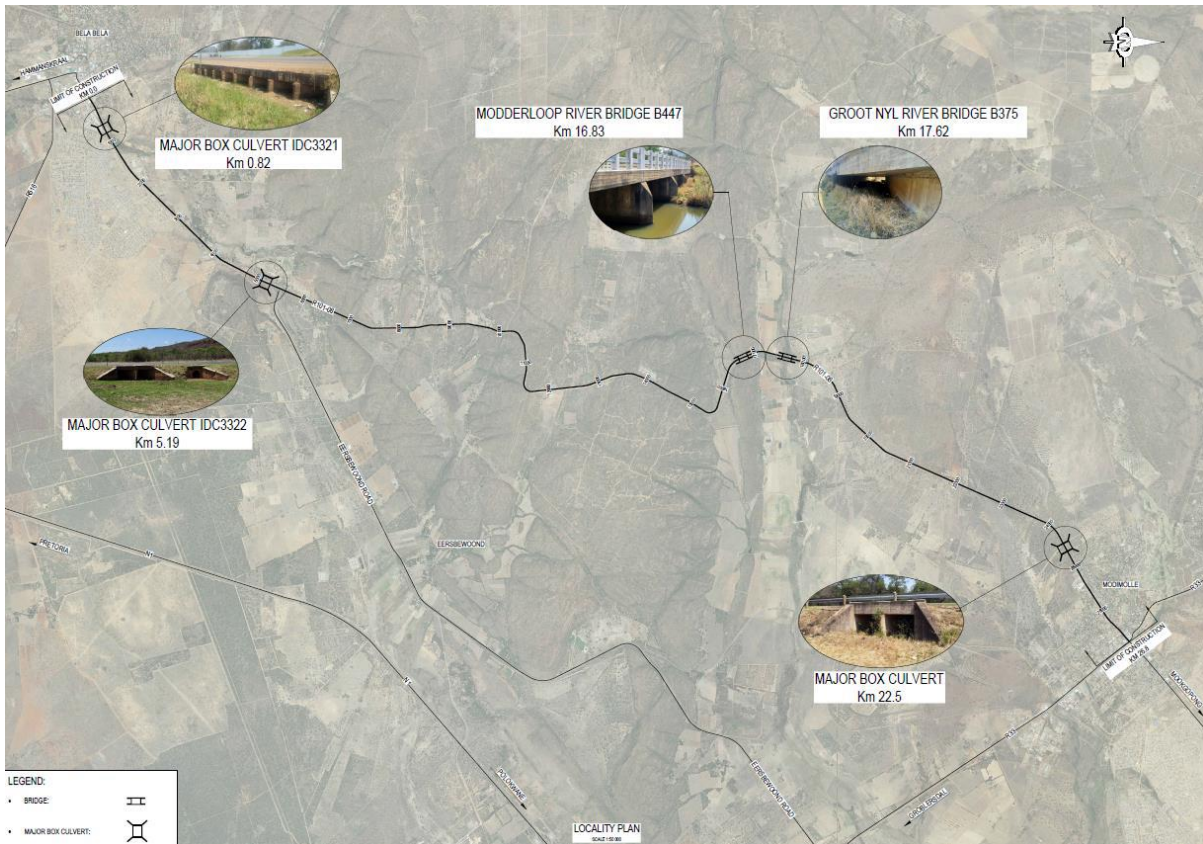
Figure 3: Hydraulic upgrade locations (BVi Consulting Engineers, 2020)

Drainage along Road R101-8 is effected through culverts and bridges. The proposed road upgrade intends to replace bridges and other structures where required for hydraulic and traffic capacity improvement and provide adequate pavement capacity for the design period. The riparian area of the Bad se Loop, Klein Kariba and Groot Nyl Rivier forms part of the study area and impacts on the rivers are anticipated during the replacement of the bridges and major culverts. **Figure 3** presents the locations and type of hydraulic infrastructure which will be replaced as part of the upgrades.
