PROJECT NRA R.101-080-2019/1

THE IMPROVEMENT OF NATIONAL ROAD
R101 SECTION 8 FROM BELA BELA (KM 0.0) TO
MODIMOLLE (KM 26.8)

FINAL PRELIMINARY DESIGN REPORT

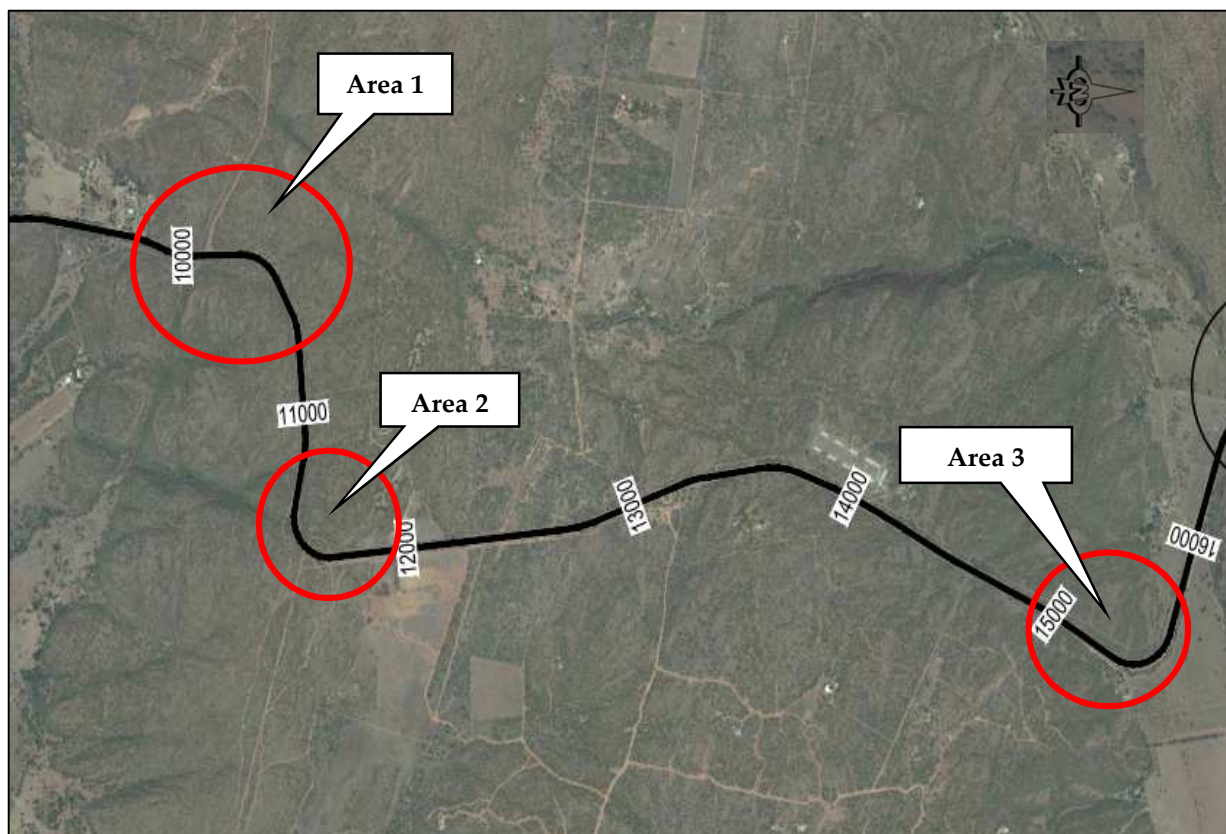
The positions of three areas in need of major horizontal realignment are indicated in *Figure 6.1*. Warning signs with posted speeds of 40 km/h were erected along these curves. The accident report showed that three accidents have recently occurred along these areas. In order to improve safety along these areas and Road R101-8 in general, design speeds of 80km/h, 90km/h and 100 km/h were assessed.

Figure 6.1: Positions of sub-standard horizontal curves (with radii <210 m).

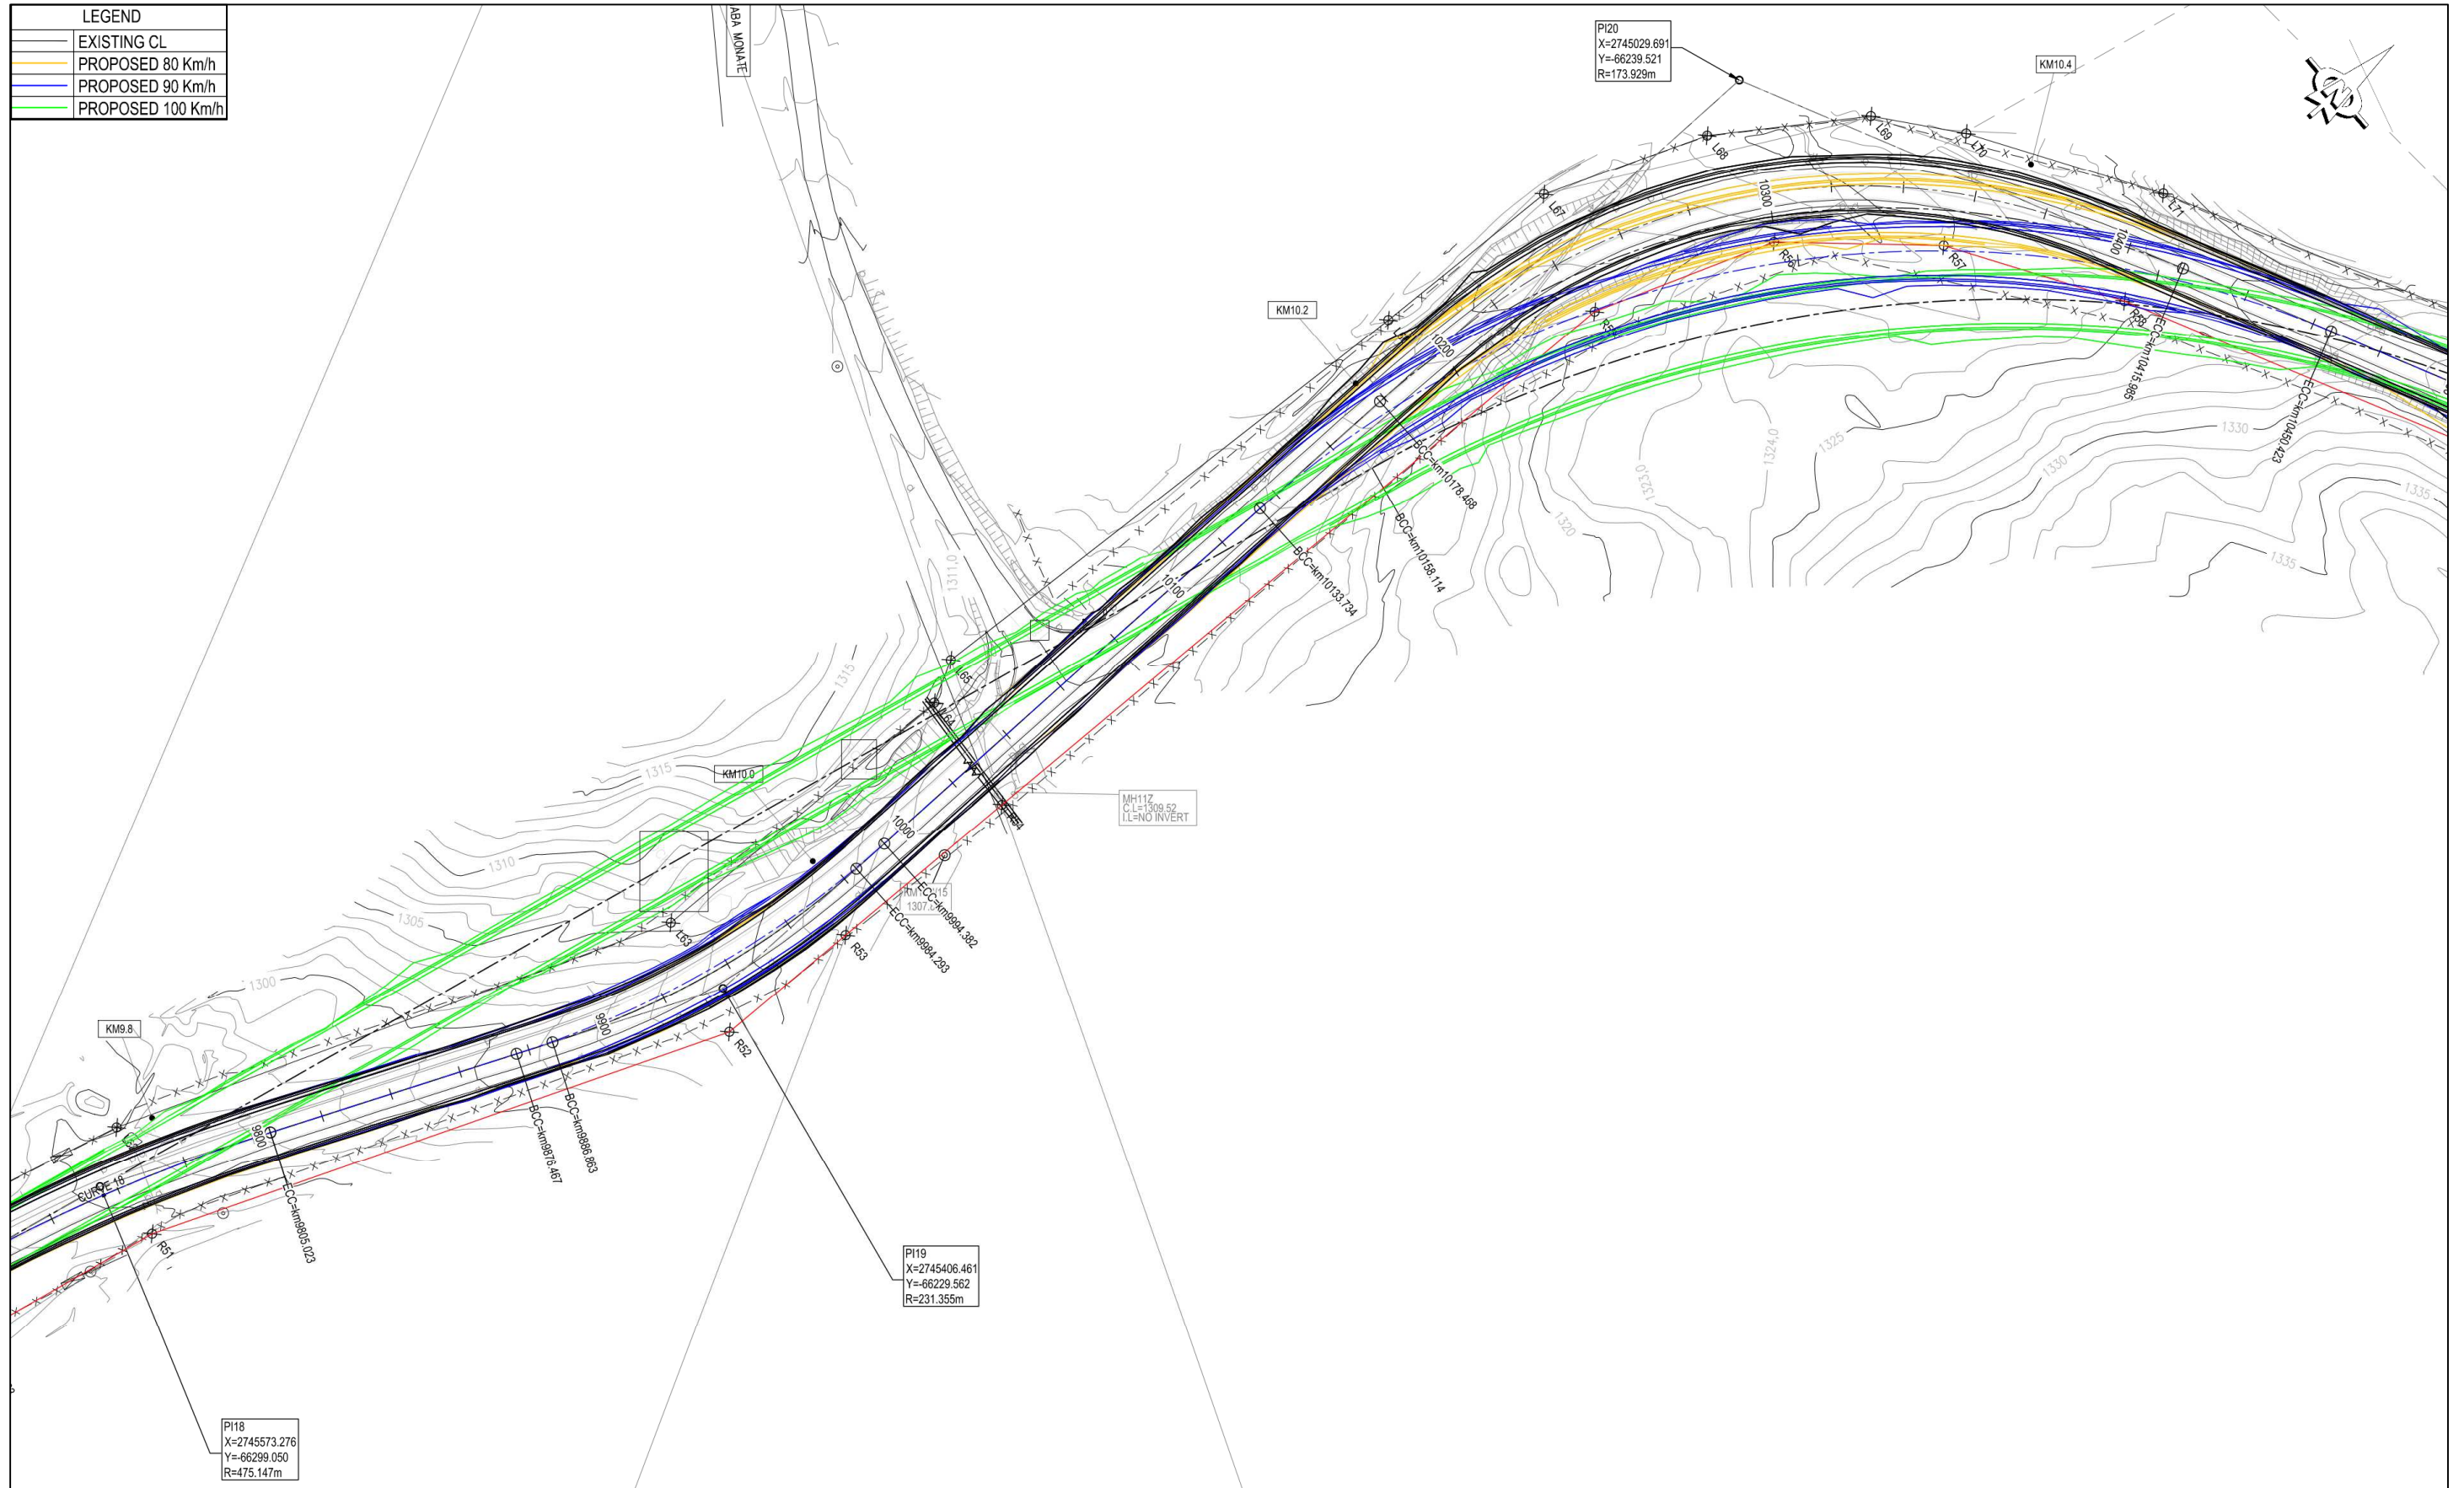
Figure 6.2: Existing and investigated alignments at Area 1 (km 9.80 to km 10.60)

As indicated in *Figure 6.2*, three sub-standard curves at Area 1 will need to be merged into a single curve to accommodate the design speed of 100 km/h. For the 90 km/h design speed, only one curve (km 10.201 to km 10.398) requires realignment, however the S-shape along Area 1 will remain a safety concern. Area 2 and 3 require new radii for all criteria.

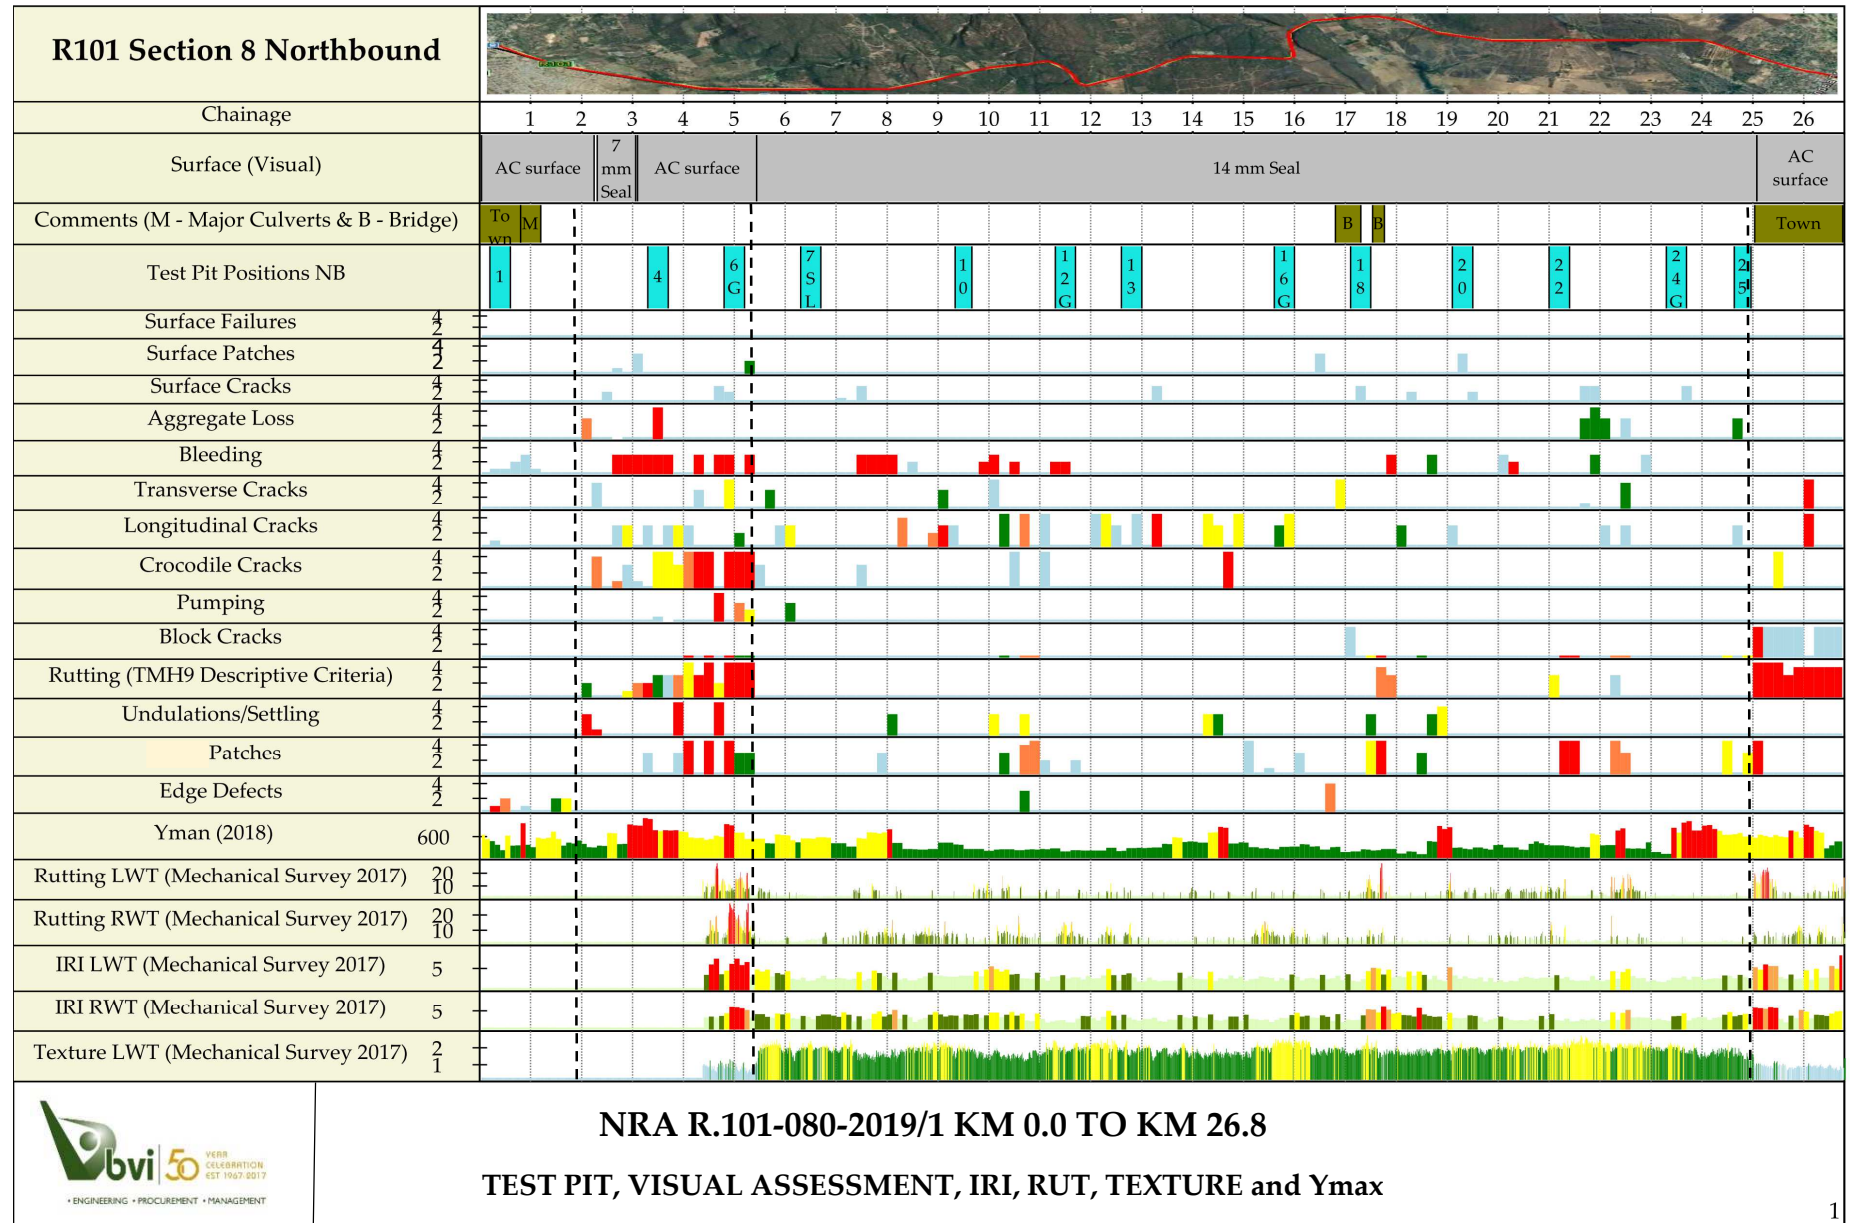
Visual assessment data was captured on strip plans using *Rubicon Toolbox* and is illustrated in *Figure 7.1* and *Figure 6.2* for the northbound and southbound lanes, respectively. The following conclusions were made from this assessment:

- The section from km 2.30 to km 5.44 is in a poor to very poor condition;
- The section from km 5.44 to km 25.05 is in a fair condition. The surfacing along this section consists of a 13.2 mm rubber seal, which tends to hide some of the structural defects due to its ability to inhibit cracks reflections, and
- The frequency and extent of patches along Road R101-8 is an indication of underlying problems. These patches probably mask the true condition of the road and will be taken into consideration in the evaluation.

Figure 7.1 Visual assessment summary, R101-8 Northbound

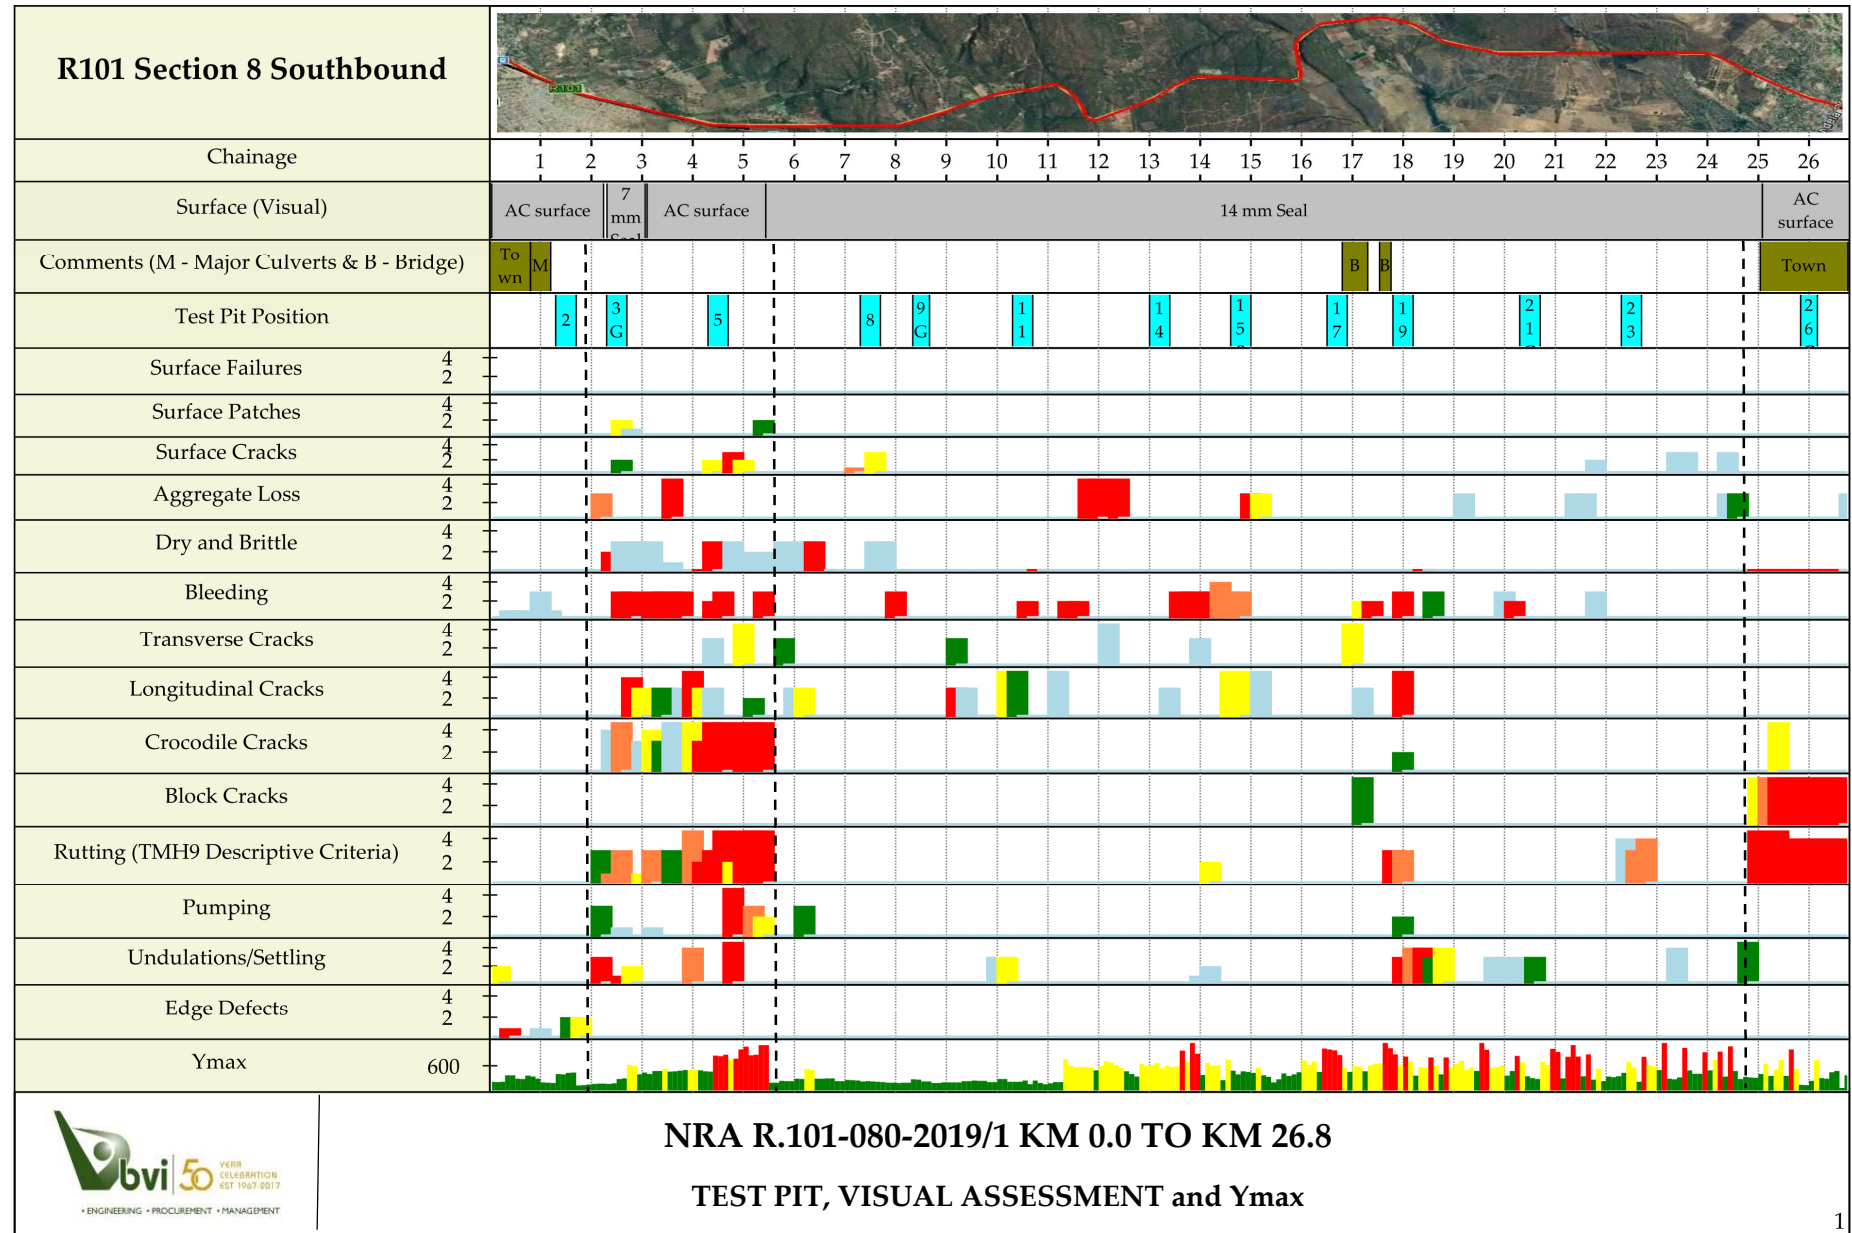
Figure 7.2: Visual assessment summary, R101-8 Southbound

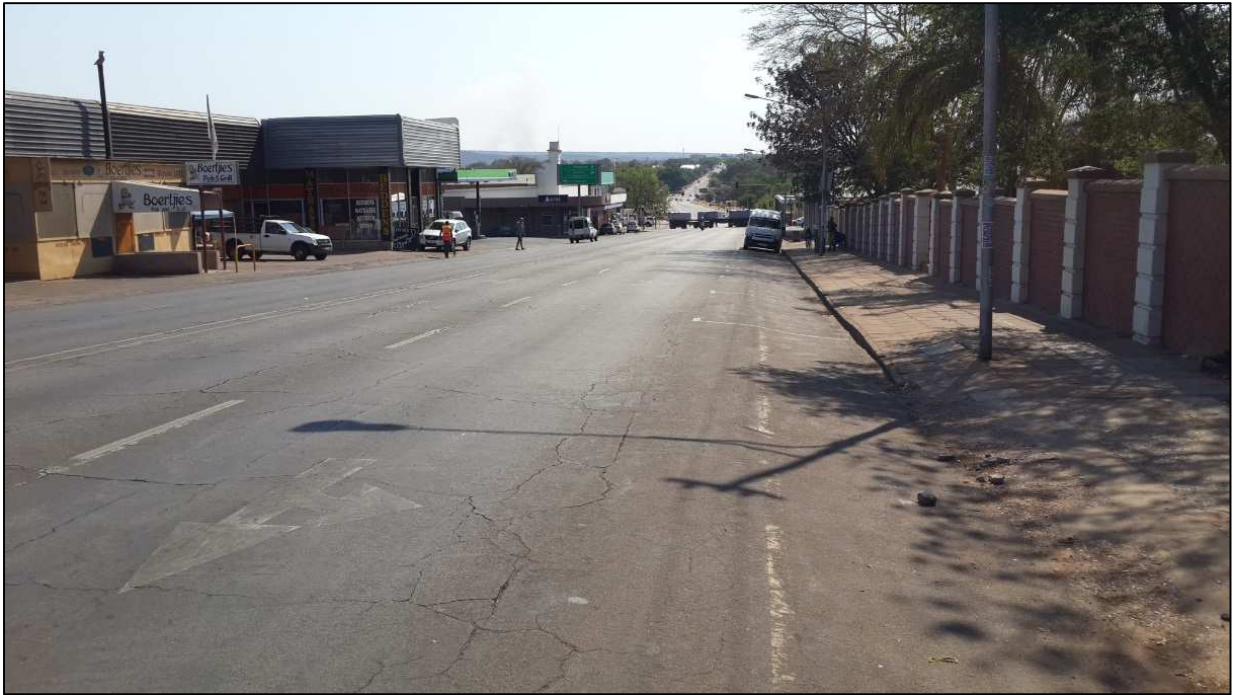
Photo 7.11: Parking bays on the right hand side km 26.60 to km 26.75

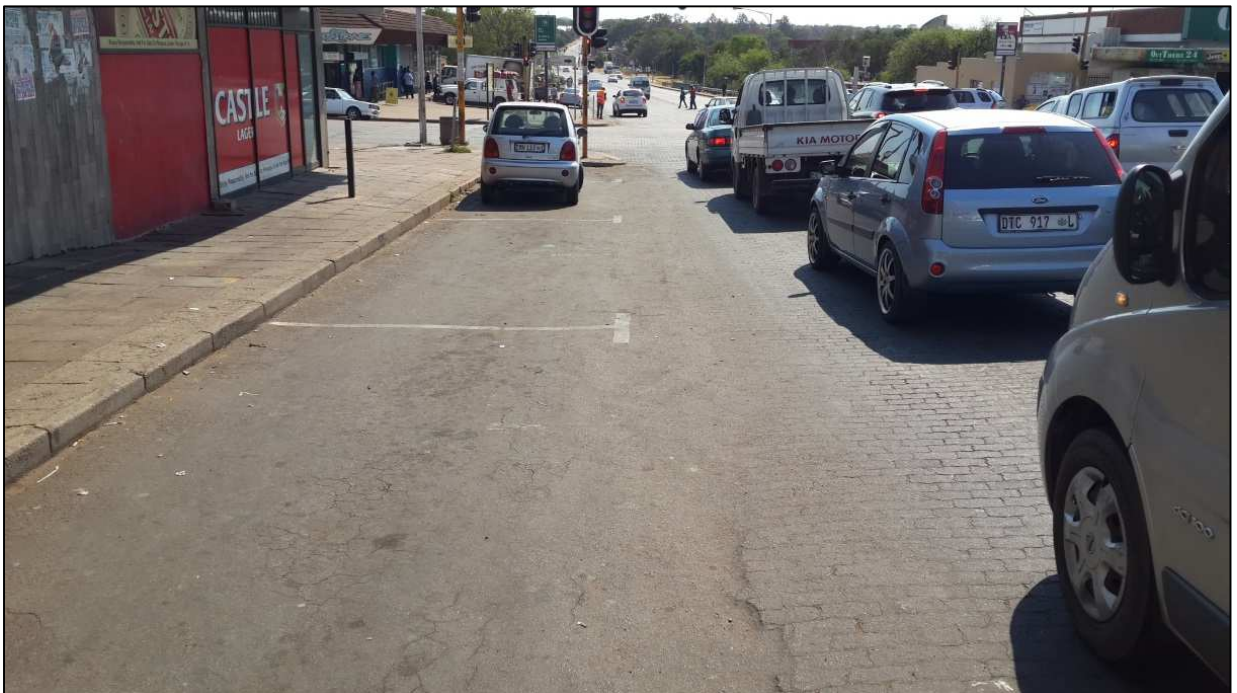
The intersection of Road R101-8 with Road R33 as well as the approaches of the slow lanes (± 25 m) were surfaced with concrete block paving (*Photo 7.12*). This area is in poor condition with poor riding quality.

Photo 7.12: Concrete block pavers at km 26.80

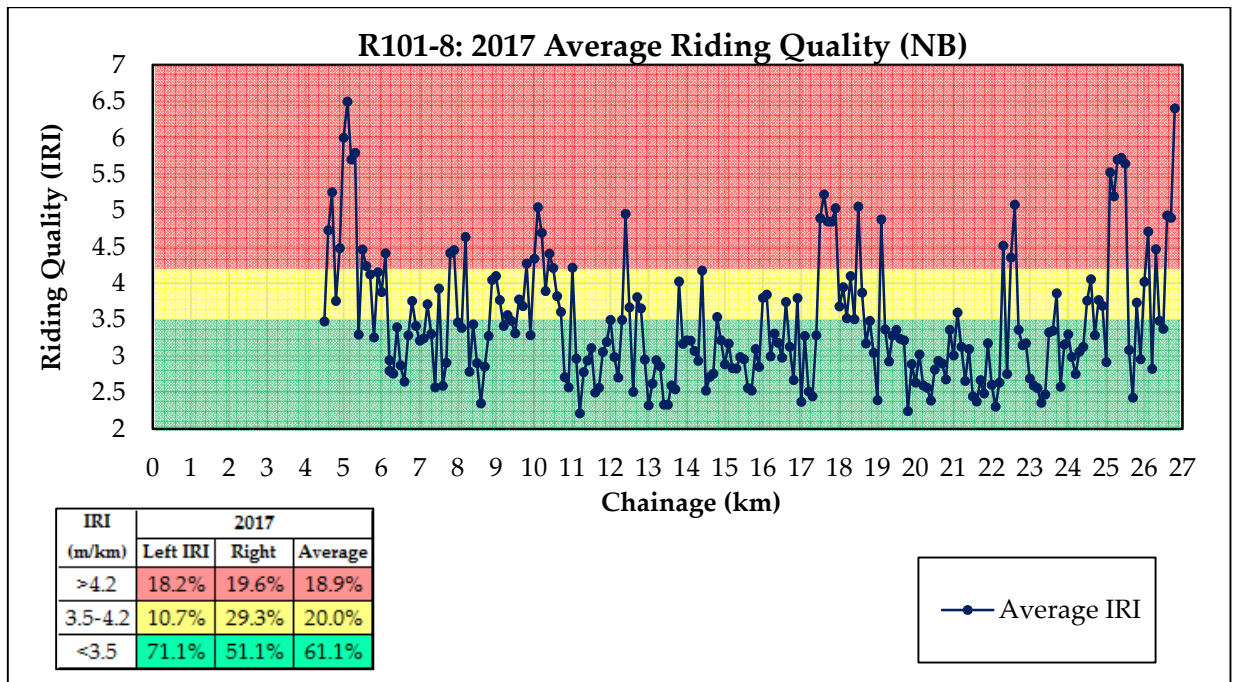
- Riding quality along the right wheel track is worse when compared to that along the left wheel track as highlighted in *Figure 7.3*; and
- Average IRI values indicate that 61% of the road is classified as sound, the remaining 20% as warning and 19% as severe;

Figure 7.3: Riding quality data in primary direction (Northbound)

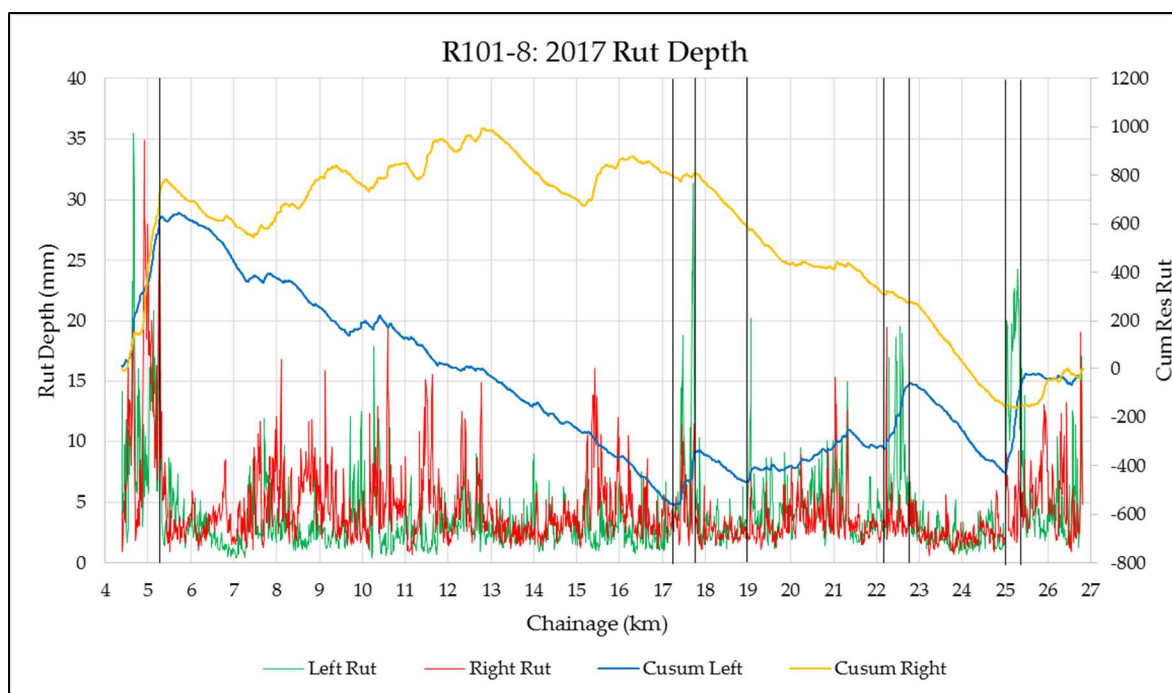
Figure 7.5 show that rut measurements along the right wheel path are generally higher compared to those along left wheel path. The fact that patch repairs have mostly been carried

- In many instances rut depth along the right wheel track is worse when compared to that along the left wheel track, similar to riding quality;
- On average, 94% of the road is classified as sound, 5% as warning and 1% as severe; and
- Based on the cusum analysis using the measurements along the left wheel track, the road can be divided into nine uniform sections.

Figure 7.5: Uniform sections based on rut depth measurements

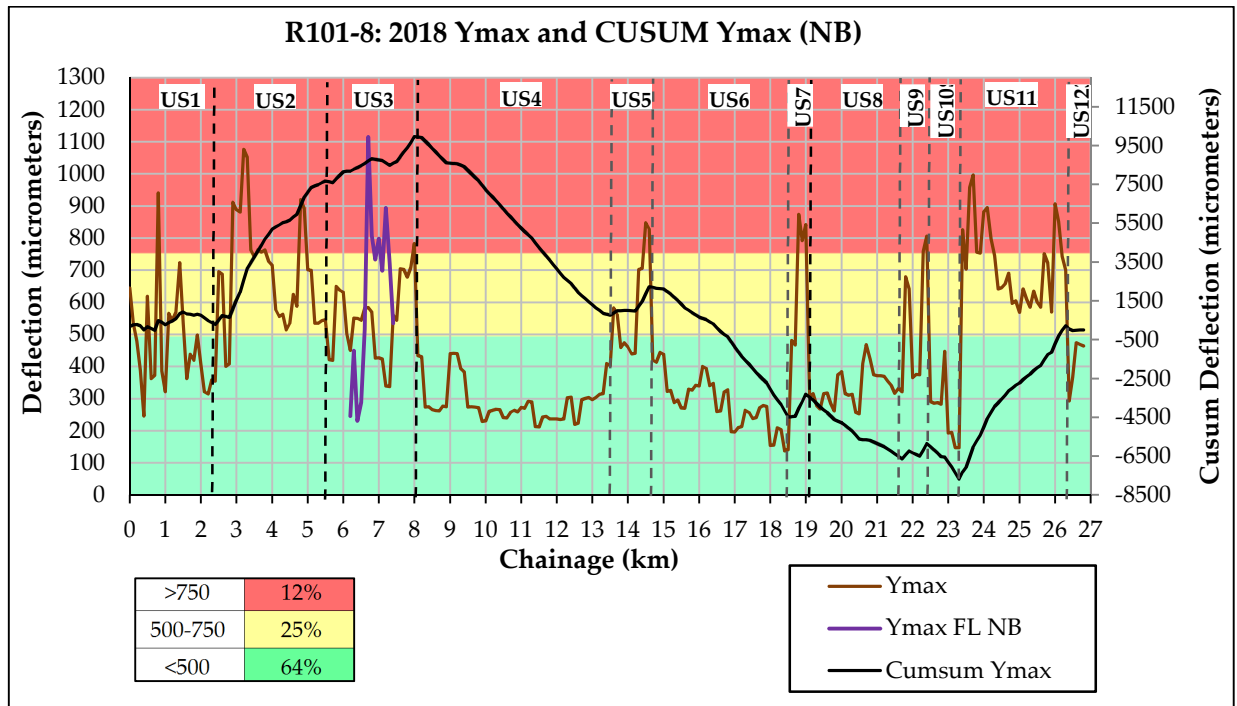
- Measurements along the northbound fast lane (km 6.2 to km 7.5) indicate that 31% of the lane can be classified as severe and 38% as warning; and
- In contrast, measurements along the southbound fast lane (km 14.4 to km 15.7) indicate that 68% can be classified as sound and 25% as warning.

Figure 7.7: Maximum deflection R101-8 Northbound lane

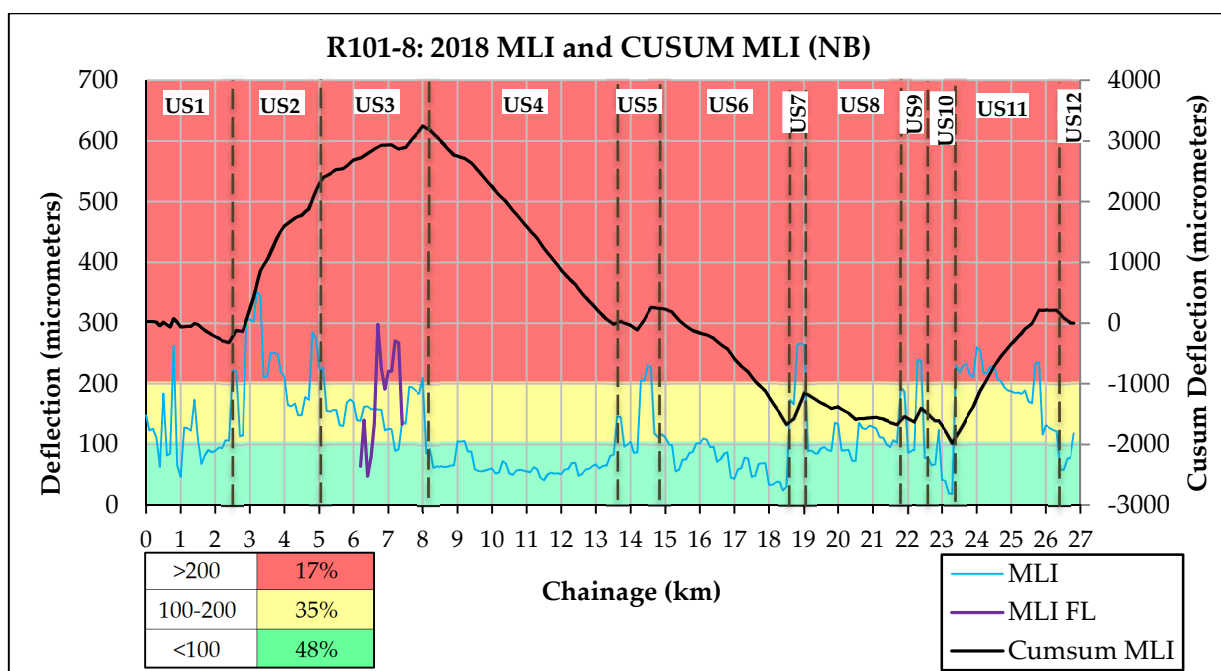
Figure 7.11: MLI and cusum MLI – Northbound lane

- MLI measurements in the northbound lane along US4 (km 8.0 to km 13.5), US6 (km15 to km 18.5), US10 (km 22.5 to km 23.5), and US12 (km 26.3 to km 26.8) are generally classified as sound. The remaining sections of the road are classified as warning and severe;
- The southbound lane from km 0.0 to km 2.5, km 5.5 to km 11.0 and km 25.5 to km 26.8 is generally classified as sound with localised warning areas. The remaining sections of the road are classified as warning and severe; and
- Measurements along the northbound fast lane are classified as severe, while that of the southbound are classified as sound to warning.

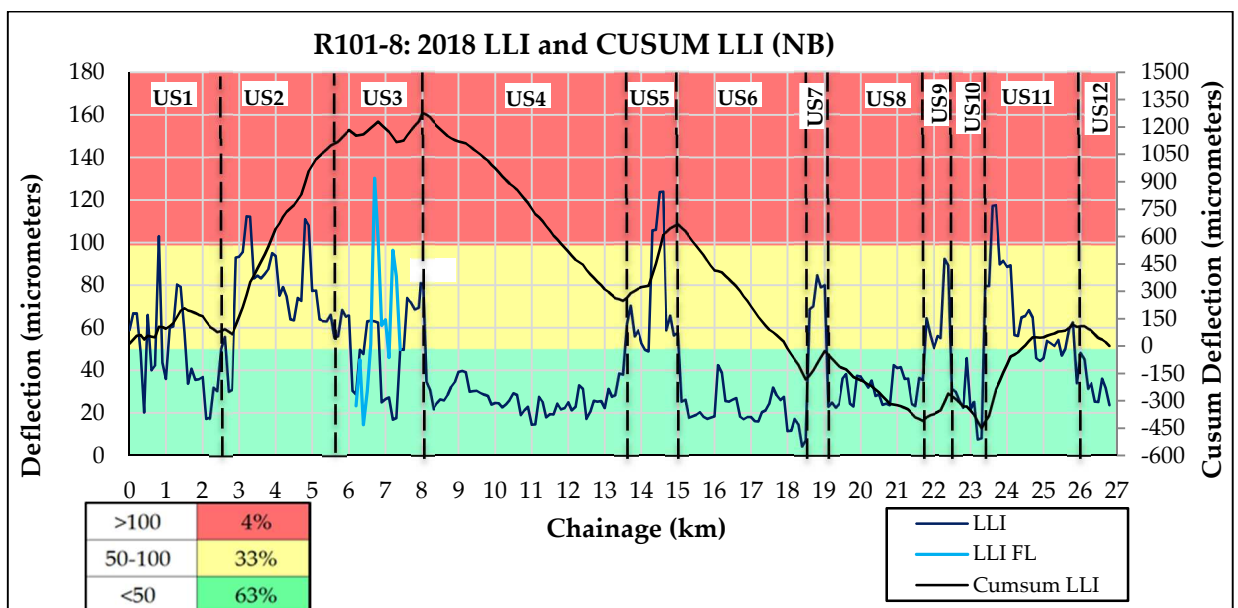
Figure 7.13: LLI and cusum LLI – Northbound

- Along the northbound lane, LLI measurements classify the road to have lower layers in sound to warning condition with localized severe areas (US1, US2, US5, US7, and US11);
- Uniform sections US2, US3, and US5 in the southbound lane appear to be the worst with warning to severe lower layers;
- Lower layers in the northbound fast lane are classified as warning, whereas in the southbound direction they are classified as sound.

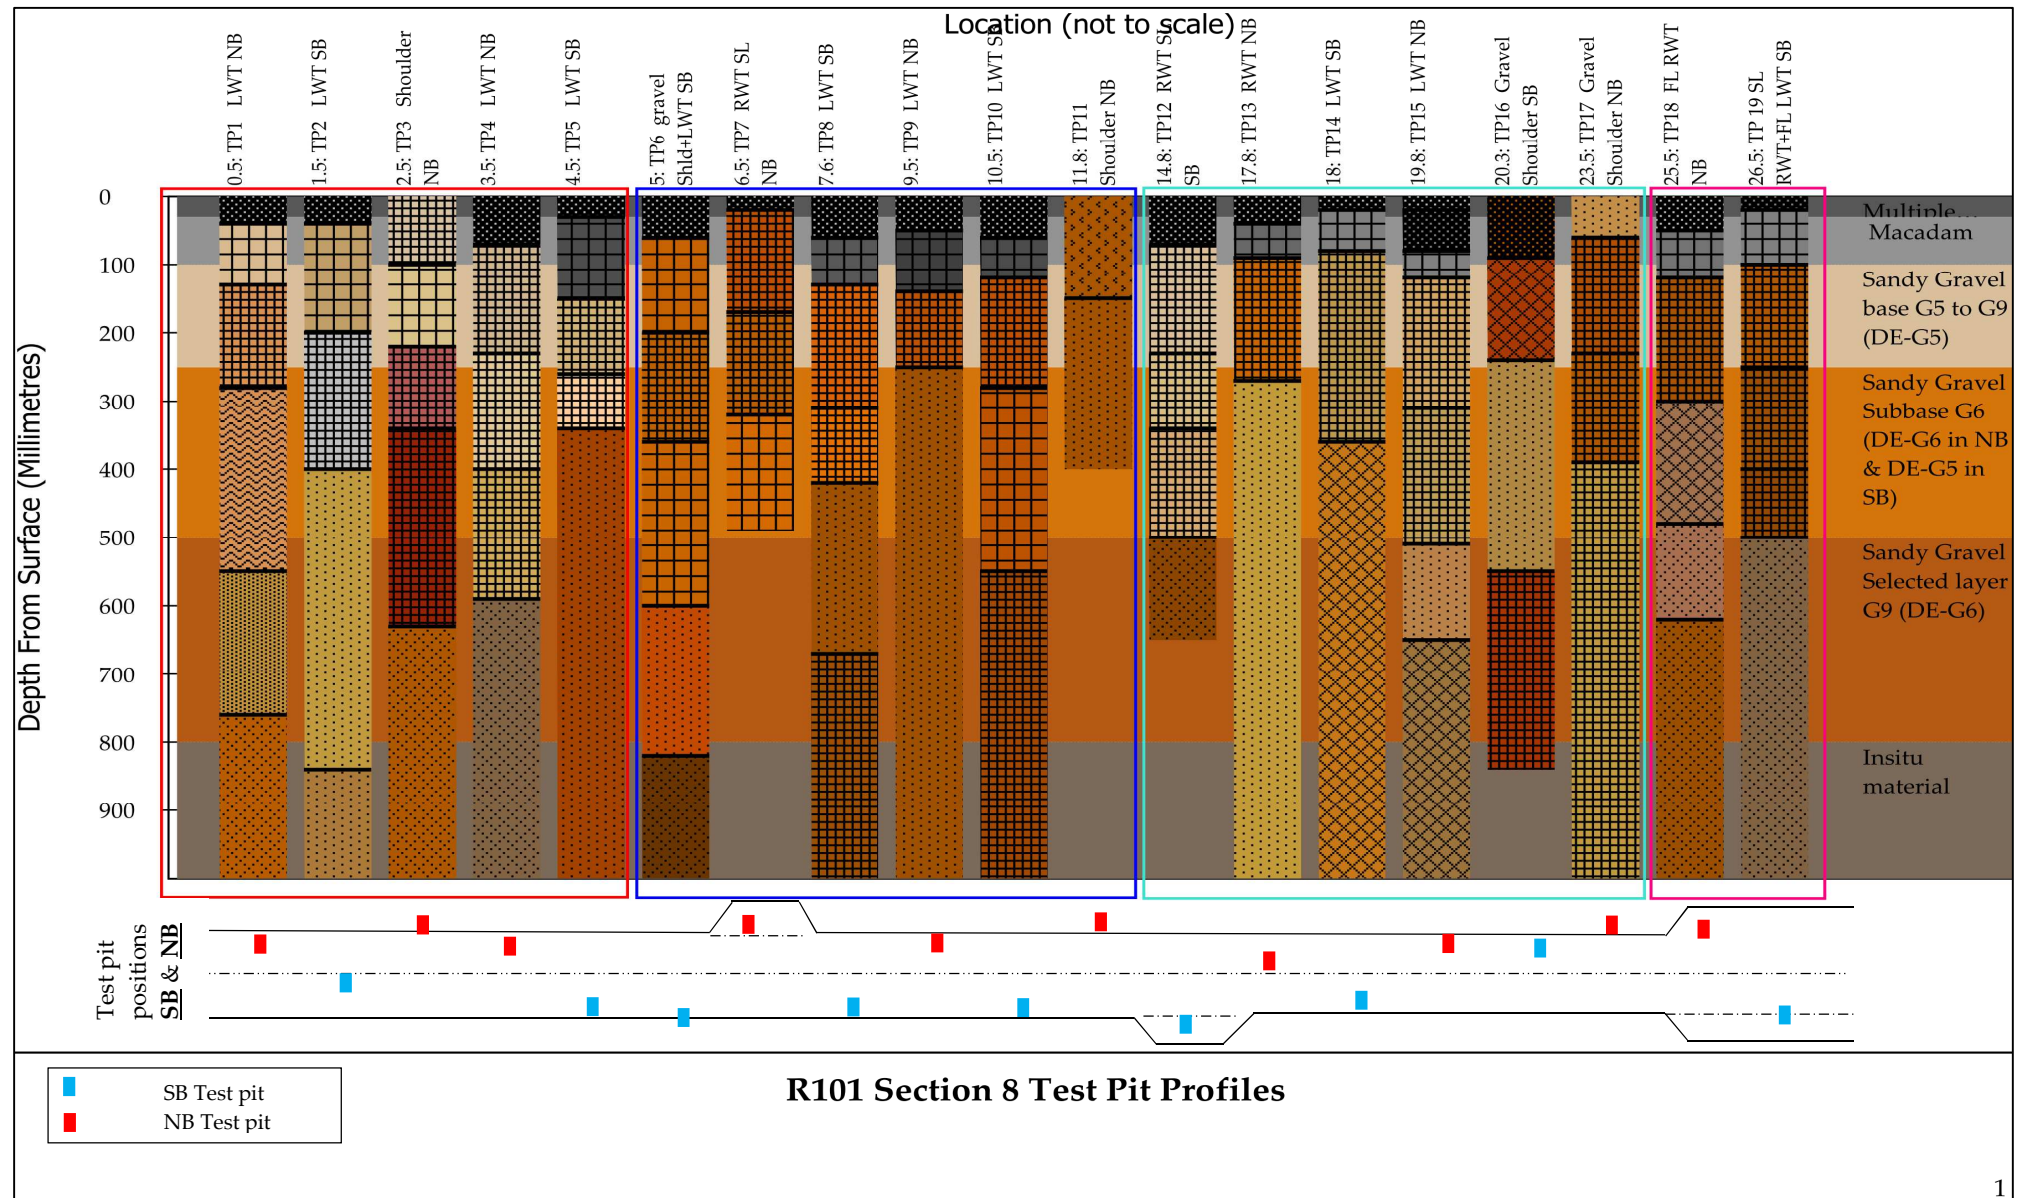
Figure 7.15: Test pit profiles and locations along Road R101-8

The field investigation was conducted from the 6th of March 2019 to 16th of March 2019. Test pit profiling showed a high variation in the pavement structure along Road R101-8 which correlates with the FWD measurements. The test pit profile summary is illustrated in *Figure 7.15*. Test pits along the section from km 5.5 to km 26.8 showed a macadam base layer with an average thickness of 80 mm instead of the 125 BTB indicated in as-built information.

- Uniform sections from the respective measurements indicate poor correlation;
- Test pit profiles indicated variation in the pavement structure which could be due to previous repair or rehabilitation actions; and

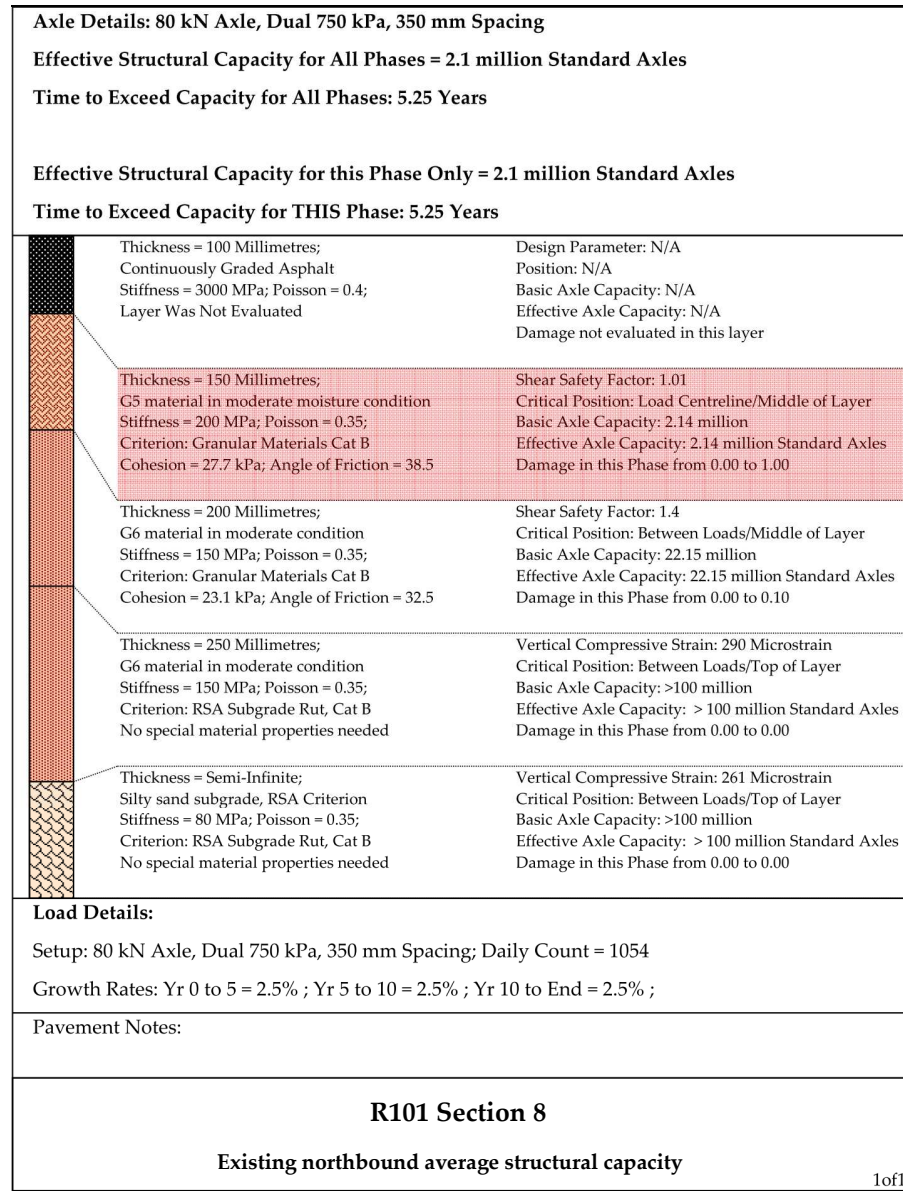
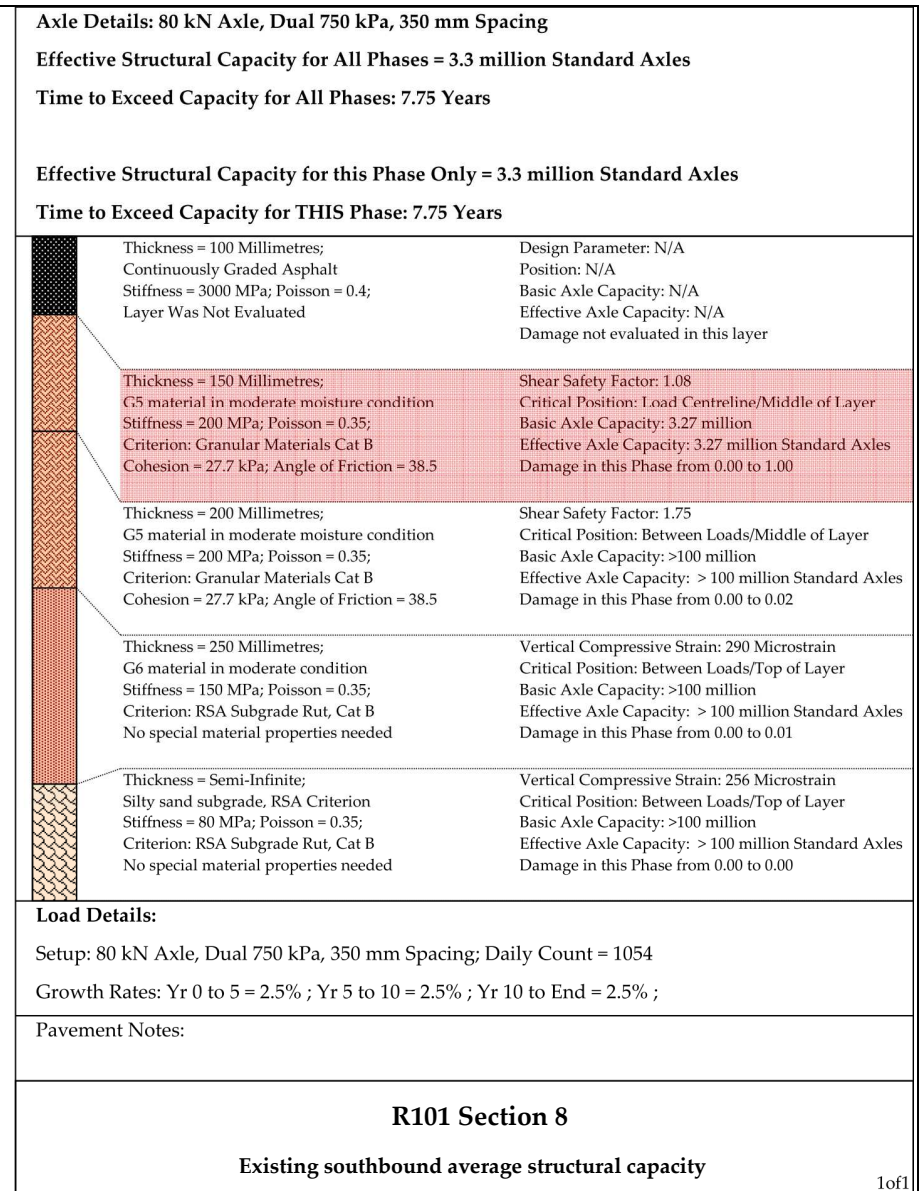
Figure 8.2: Linear Elastic pavement analyses for NB and SB lanes

The outcome of the SAMPDM analysis for the northbound and southbound lanes is illustrated in *Figure 8.2* and shows remaining capacity of 2.1 and 3.3 million E80’s, respectively.

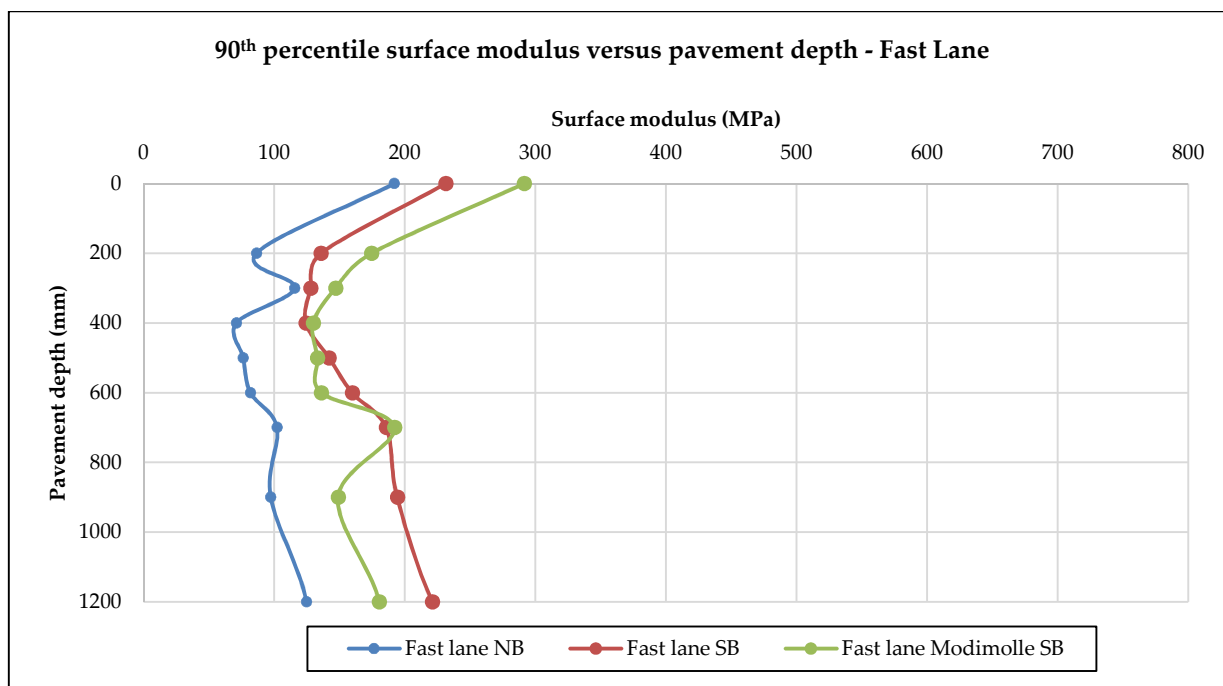
Figure 8.5: The 90th percentile surface modulus for fast lanes NB and SB

The surface modulus 90th percentile plot for the fast lanes indicate that the subgrade layers for all sections exhibit stress softening with the northbound fast lane having subgrade layer stiffnesses between 82 and 125 MPa and southbound between 136 MPa and 221 MPa.

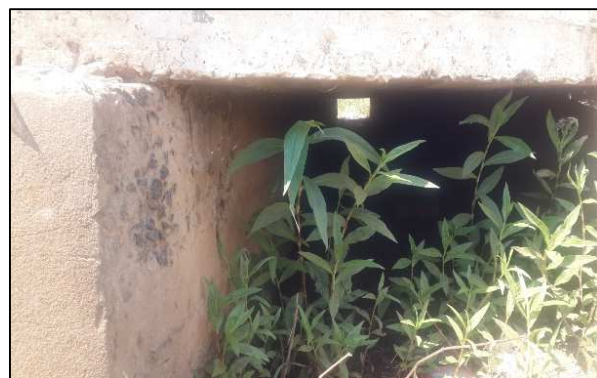
Figure 11.7: Cell overgrowth

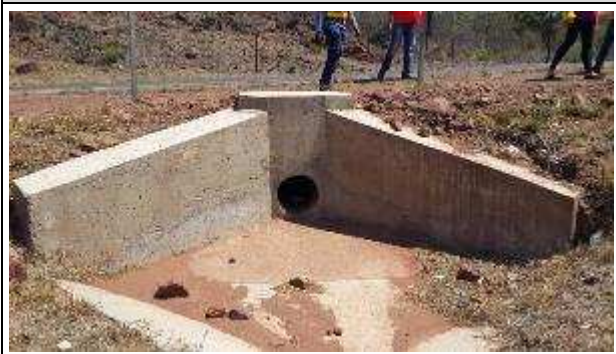
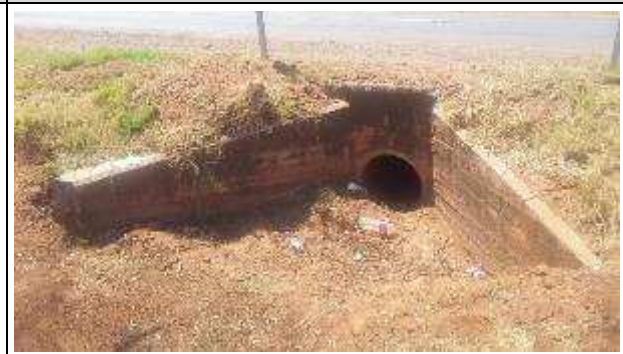
<p>New outlet head wall for Ø 900 pipe culvert @ km 6.500</p>	<p>Fair condition head wall for Ø 900 pipe culvert @ km 3.900</p>

The improvement to accommodate a 3.7 m lanes and 3 m surfaced shoulders will require extension of all culvert structures and construction of new side drains. As a result new in- and outlet structures will be constructed. Misaligned culverts will be rehabilitated and damaged pipes will be replaced. Damaged or missing danger plates will be replaced.
