PROJECT NRA R.101-080-2019/1

THE IMPROVEMENT OF NATIONAL ROAD
R101 SECTION 8 FROM BELA BELA (KM 0.0) TO
MODIMOLLE (KM 26.8)

FINAL PRELIMINARY DESIGN REPORT

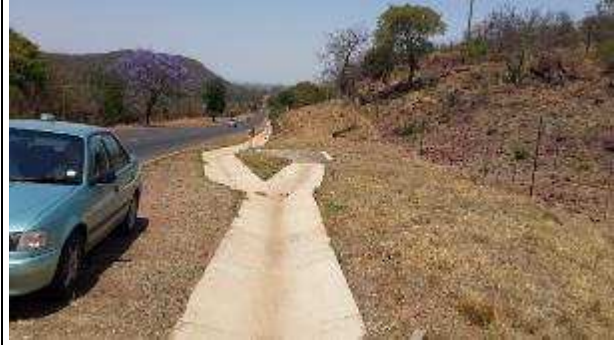
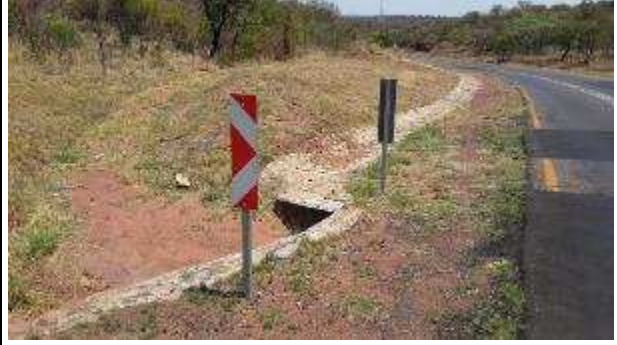
<p align="center">Concrete side drain @ km 6.600</p>	<p align="center">Stone pitch drain @ km 10.650</p>

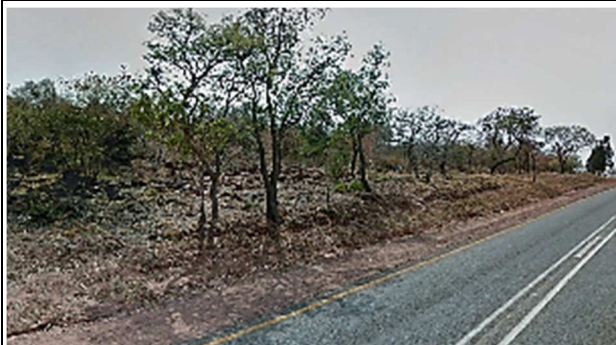
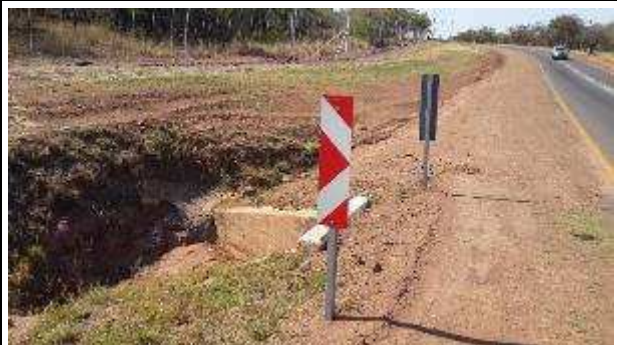
<p align="center">Earth drain @ km 11.200</p>	<p align="center">Earth drain @ km 21.850</p>

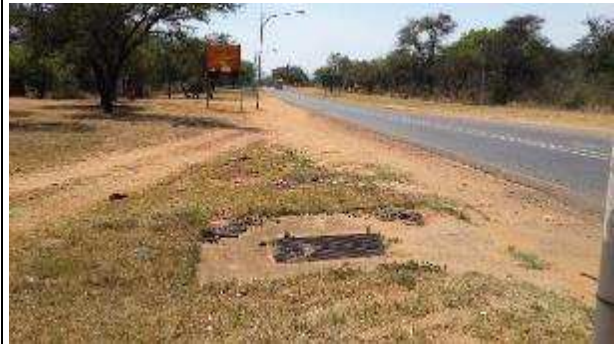
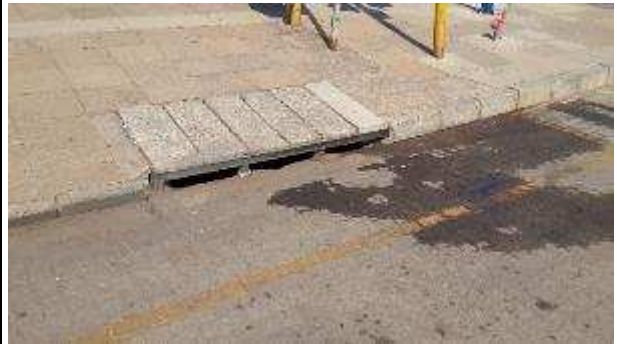
<p align="center">Catch pit in Modimolle @ km 24.880</p>	<p align="center">Kerb inlet in Modimolle @ km 26.800</p>

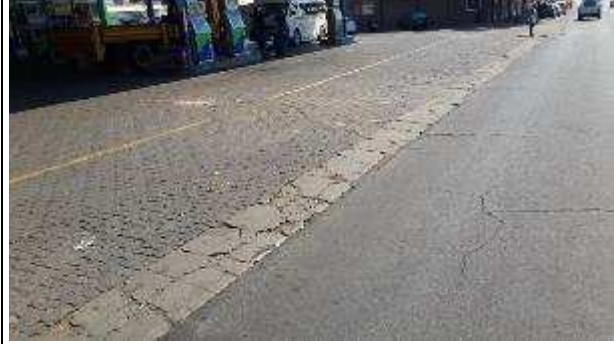
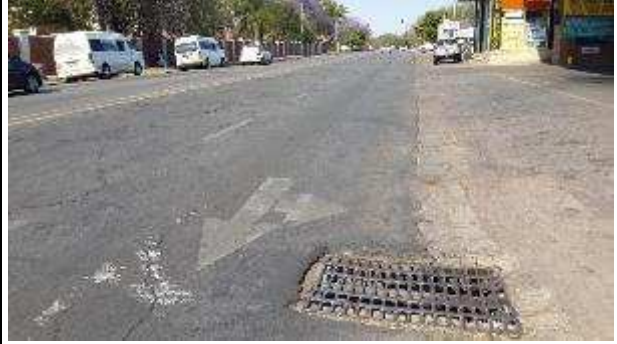
Figure 12.4: Road side drains (concrete, stone pitching and earth drains)

The section through Modimolle appears to have a piped storm water system situated on the left side of the road with drainage effected through catch pits and kerb inlets. The section from km 25.35 to km 26.80 includes a cast in-situ concrete lined drain between the traffic lanes and parking bays. The condition of these drains is poor to very poor as indicated in *Figure 12.4*.

<p align="center">Shattered concrete kerbs in Modimolle @ km 26.700</p>	<p align="center">Catch pit in Modimolle @ km 26.740</p>

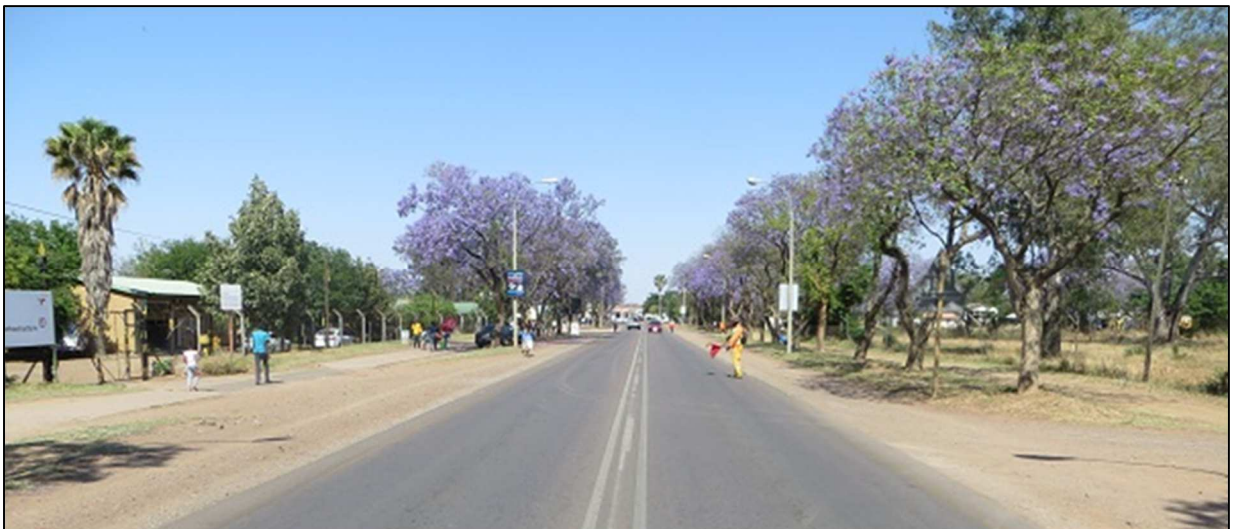
There are existing high pressure sodium (HPS) lights installed along the town sections within Bela Bela and Modimolle. These street lights appear to be in fair condition and are functional. The existing street light fittings installed are not consistent throughout each town. In certain parts the lights are in a single arrangement and along other sections lights are in an opposite arrangement.

In Bela Bela the existing street lights only cover the first 700 m of the road and there are no street lights for the rest of the urban section. Within Modimolle overhead lines provide power to the street lights.

Photo 13.1: Street light fittings in opposite arrangement in Bela Bela

Due to the proposed widening improvements, the position of current lights will need to be relocated and new lights provided where pedestrian traffic dictates. The street lighting services will be designed and installed according to all relevant street lighting standards and regulations.

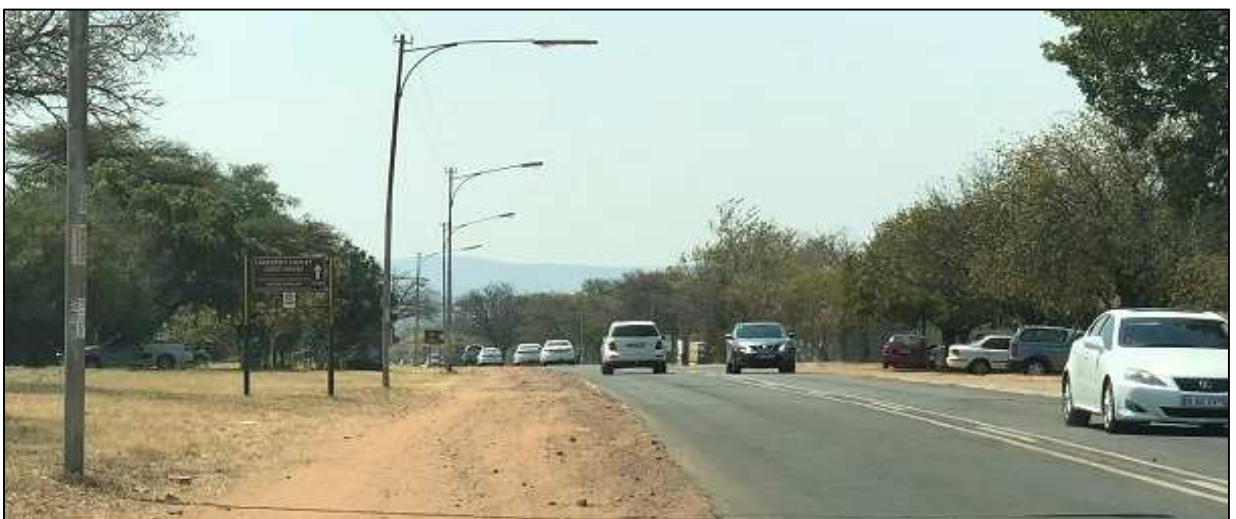
Photo 13.2: Two types of street light fittings installed in Modimolle on the Left hand side
